# **SERVICE BULLETIN**

**Owner's Service Bulletin – OSB 29 Draft Issue 1**

**Applicability – Ikarus C42 all models**

**Inspection of main fuselage tube for cracking around cut-outs**

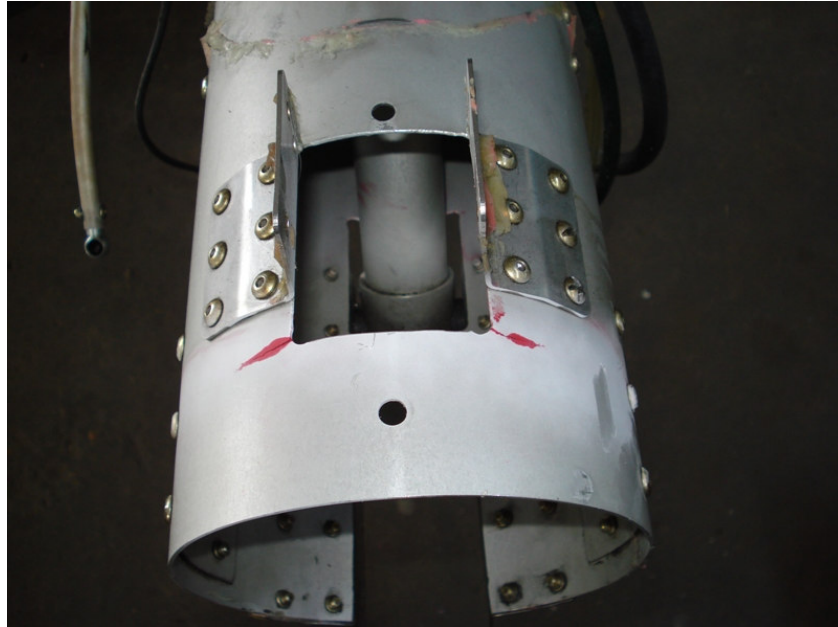
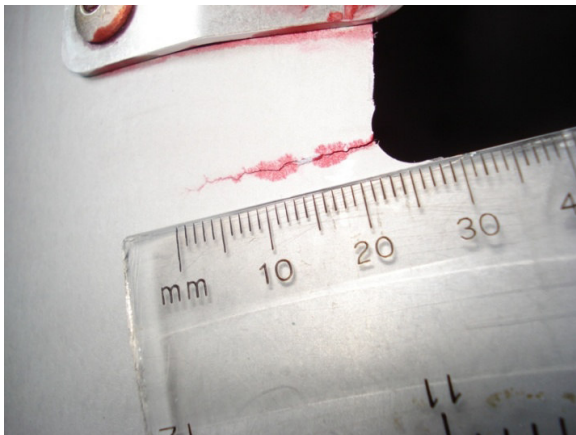
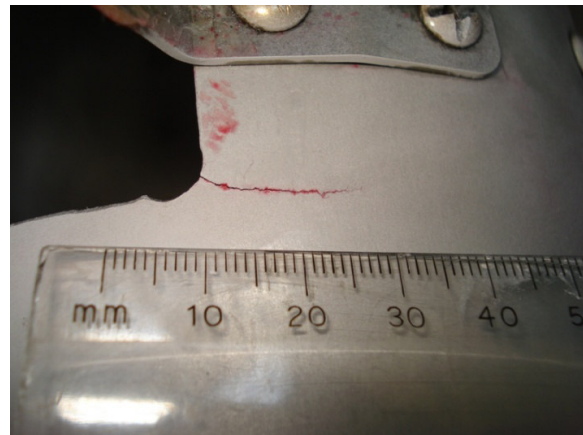
High hours examples of early C42 aircraft have exhibited cracks emanating from the corners of the cut-outs in the main fuselage tube where the nose-leg and A-strut are fitted.

If such cracks are allowed to propagate the structural integrity of the nose-leg, A-strut and engine mountings may be compromised.

Example cracks on upper surface of main fuselage tube around A-strut cut-out.

The perimeter of the cut-outs in the main fuselage tube where the nose-leg and A-strut pass through the main fuselage tube must be visually inspected for cracking, with particular attention paid to the corners.

If any cracking is found please contact Red Aviation. An approved repair scheme involving the fitment of an inner sleeve to the forward end of the main fuselage tube is available.

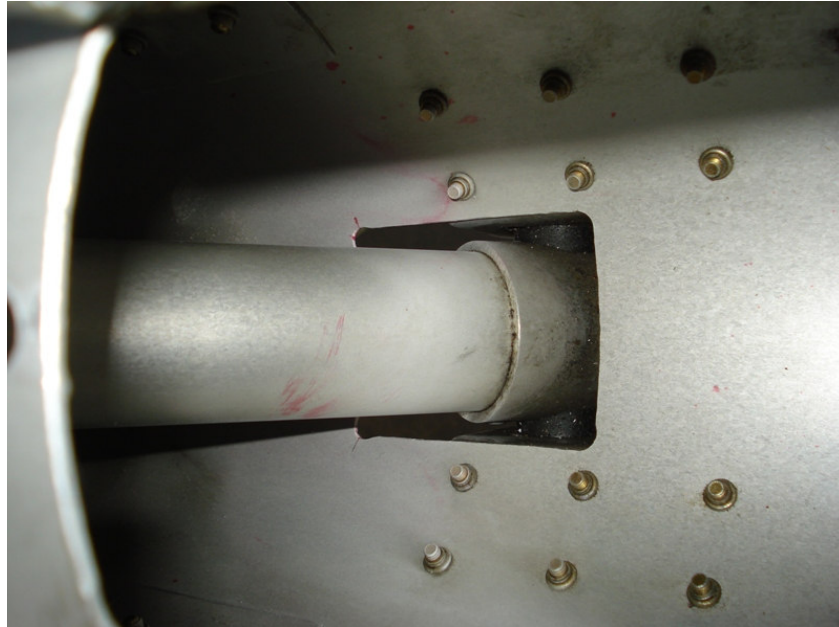
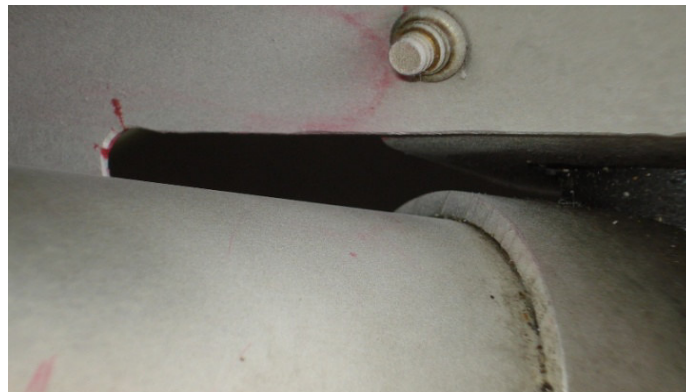
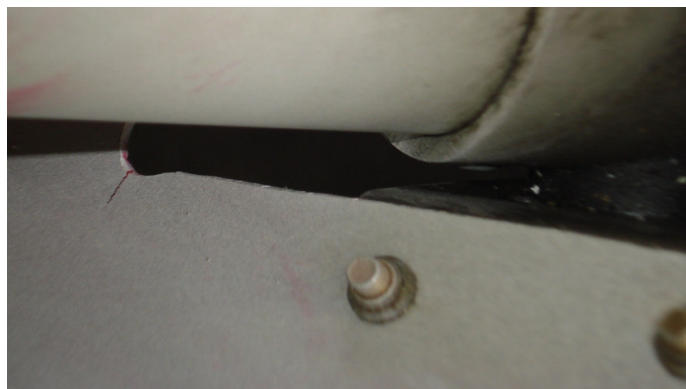
Example cracks on lower surface of main fuselage tube around nose-leg cut-out.
