SERVICE BULLETIN

Owner's Service Bulletin – OSB 29 Draft Issue 1

Applicability – Ikarus C42 all models

Inspection of main fuselage tube for cracking around cut-outs

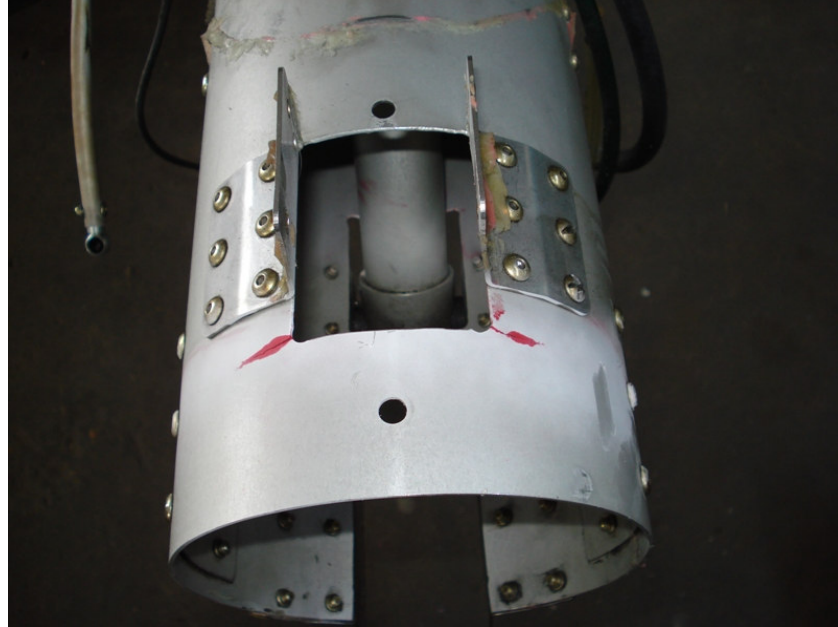
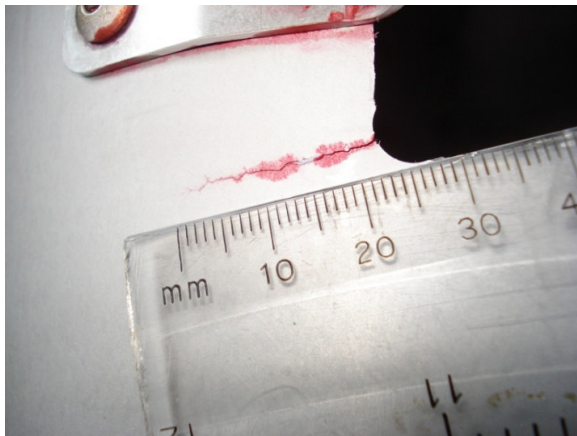
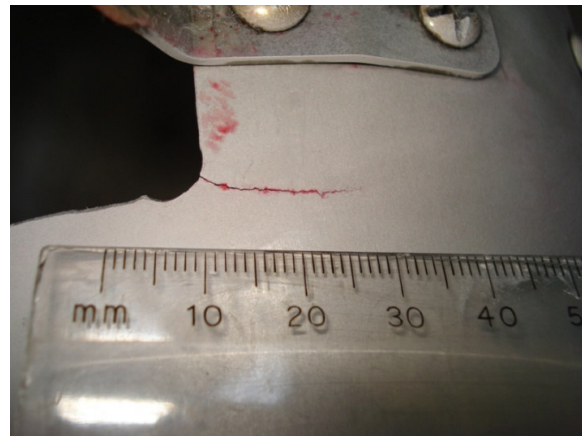
High hours examples of early C42 aircraft have exhibited cracks emanating from the corners of the cut-outs in the main fuselage tube where the nose-leg and A-strut are fitted.

If such cracks are allowed to propagate the structural integrity of the nose-leg, A-strut and engine mountings may be compromised.

Example cracks on upper surface of main fuselage tube around nose-leg cut-out.

The perimeter of the cut-outs in the main fuselage tube where the nose-leg and A-strut pass through the main fuselage tube must be visually inspected for cracking, with particular attention paid to the corners.

If any cracking is found please contact Red Aviation. An approved repair scheme involving the fitment of an inner sleeve to the forward end of the main fuselage tube is available.

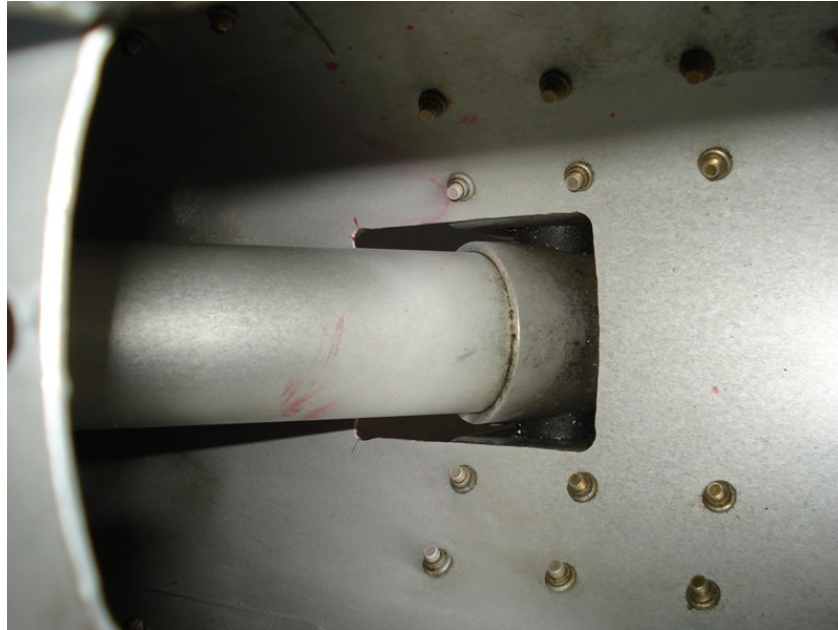
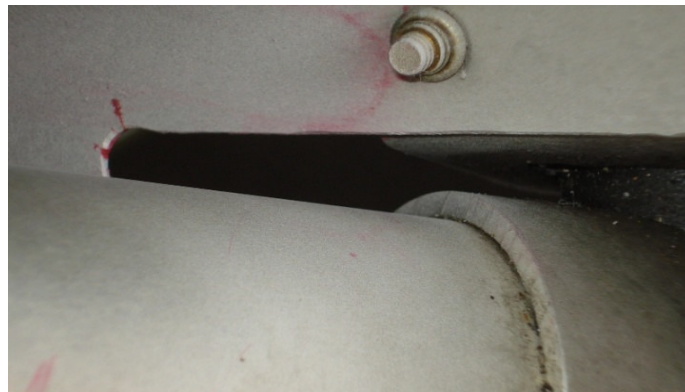
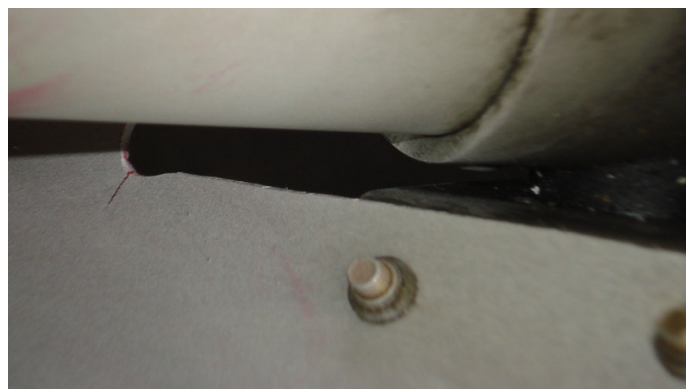
Example cracks on lower surface of main fuselage tube around A-strut cut-out.
