SERVICE BULLETIN

Owner's Service Bulletin – OSB 29 Draft Issue 1

Applicability – Ikarus C42 all models

Inspection of main fuselage tube for cracking around cut-outs

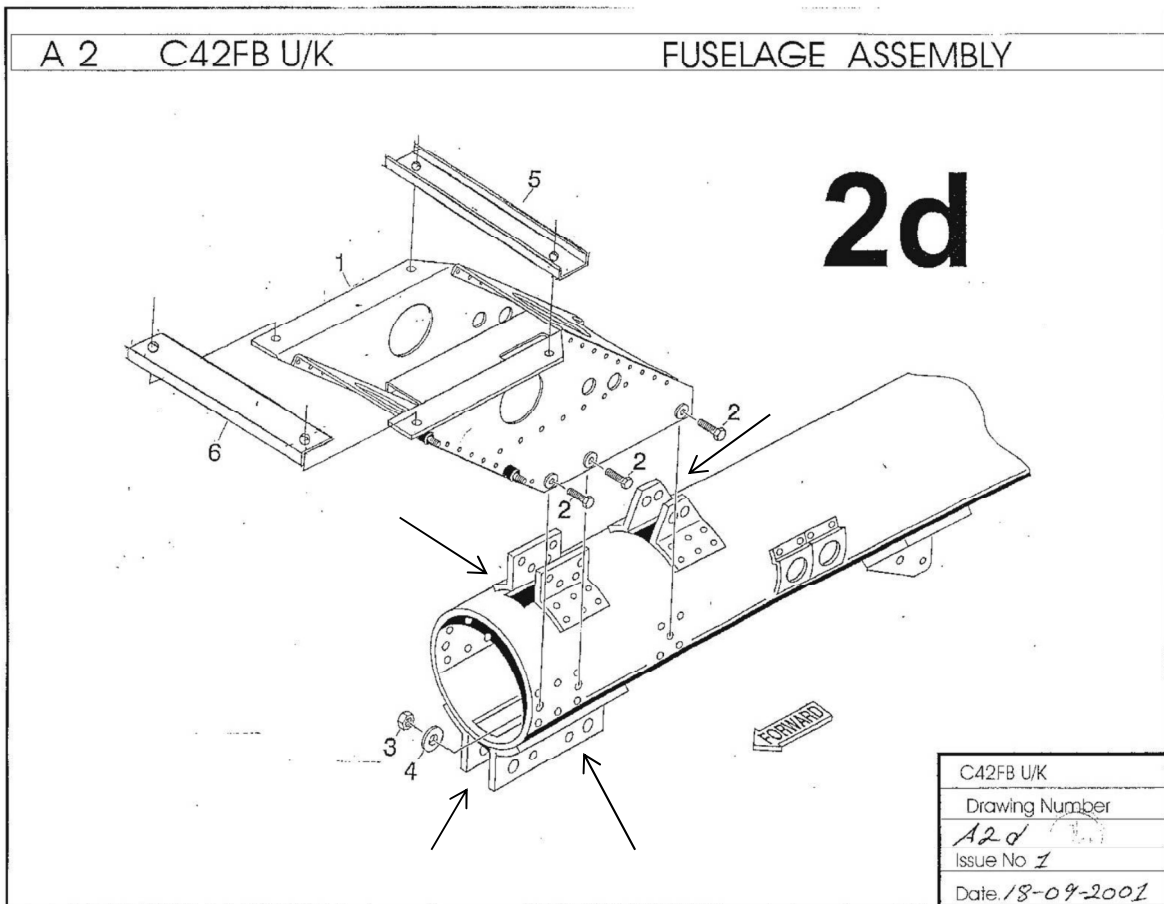
Nose-leg and A-strut cut-outs at front of main fuselage tube in vicinity of engine mount.

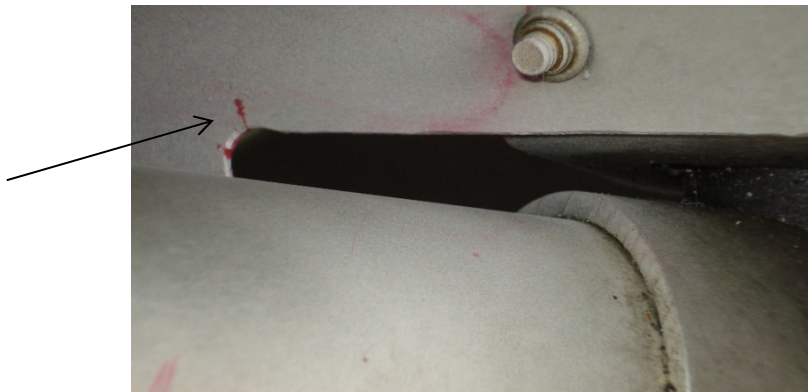
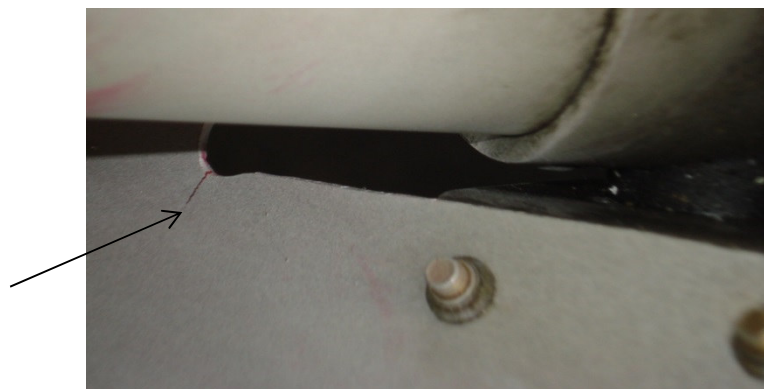
High hours examples of early C42 aircraft have exhibited cracks emanating from the corners of the cut-outs in the main fuselage tube where the nose-leg and A-strut are fitted.

Example cracks on lower surface of main fuselage tube at corners around A-strut cut-out.

If any cracking is found please contact Red Aviation. An approved repair scheme involving the fitment of an inner sleeve to the forward end of the main fuselage tube is available.

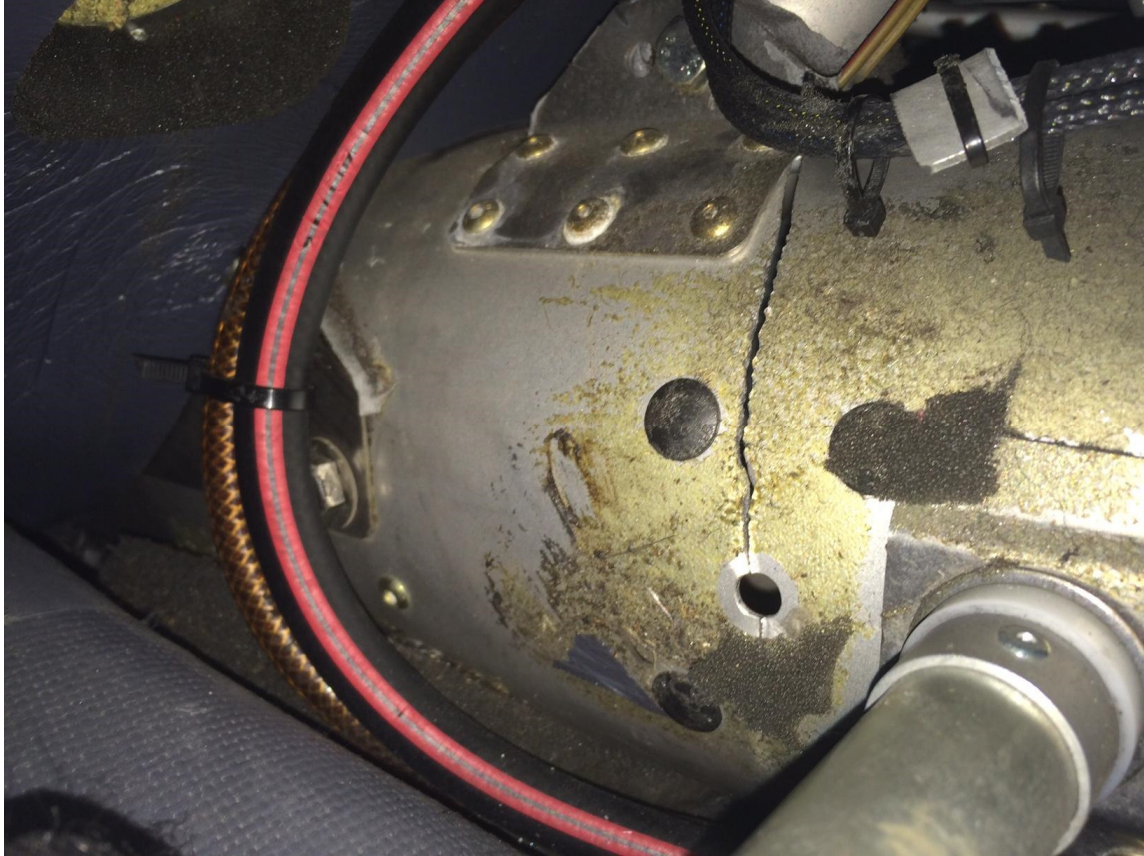
Example of significant crack allowed to propagate on 4500hr aircraft. This crack was hidden by the firewall sound-deadening foam. Ensure that it is removed for inspection.

Remove the area of sound-deadening foam on the cockpit side of the firewall which hinders inspection of the A-strut cut-out just forward of the rudder pedals on the top of the main fuselage tube. This is the area which concealed the significant crack shown in the example photographs above.
