# **SERVICE BULLETIN**

**Owner's Service Bulletin – OSB 29 Draft Issue 1**

**Applicability – Ikarus C42 all models**

**Inspection of main fuselage tube for cracking around cut-outs**

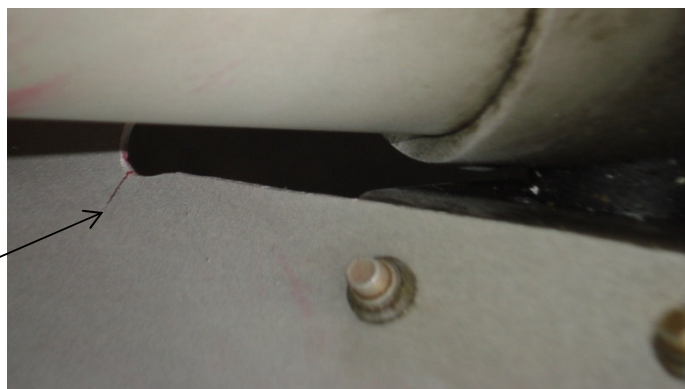
High hours examples of early C42 aircraft have exhibited cracks emanating from the corners of the cut-outs in the main fuselage tube where the nose-leg and A-strut are fitted.

Example cracks on lower surface of main fuselage tube at corners around A-strut cut-out.

The perimeter of the cut-outs in the main fuselage tube where the nose-leg and A-strut pass through the main fuselage tube must be visually inspected for cracking, with particular attention paid to the corners.

If any cracking is found please contact Red Aviation. An approved repair scheme involving the fitment of an inner sleeve to the forward end of the main fuselage tube is available.

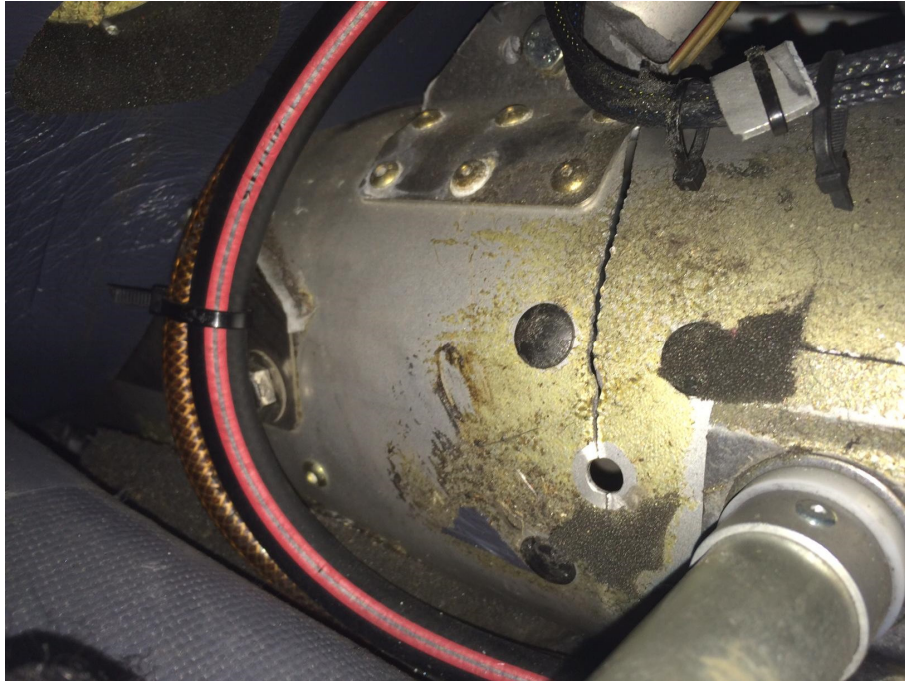
Example of significant crack allowed to propagate on 4500hr aircraft. This crack was hidden by the firewall sound-deadening foam. Ensure that it is removed for inspection.

Remove the area of sound-deadening foam on the cockpit side of the firewall which hinders inspection of the A-strut cut-out just forward of the rudder pedals on the top of the main fuselage tube. This is the area which concealed the significant crack shown in the example photographs above.

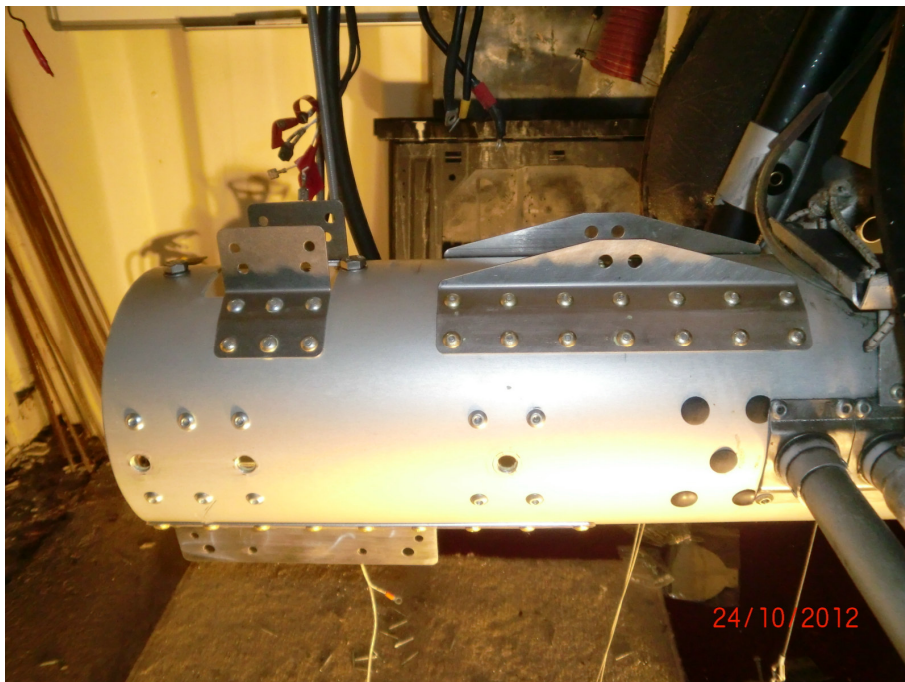
Lengthened A-strut top attachment brackets as found on aircraft from around 2007.
