## **Owner's Service Bulletin – OSB 31 Issue 1.0**

**Applicability – Ikarus C42A & B models with A-strut passing through main fuselage tube**

**Inspection of inside of A-strut for cracking**

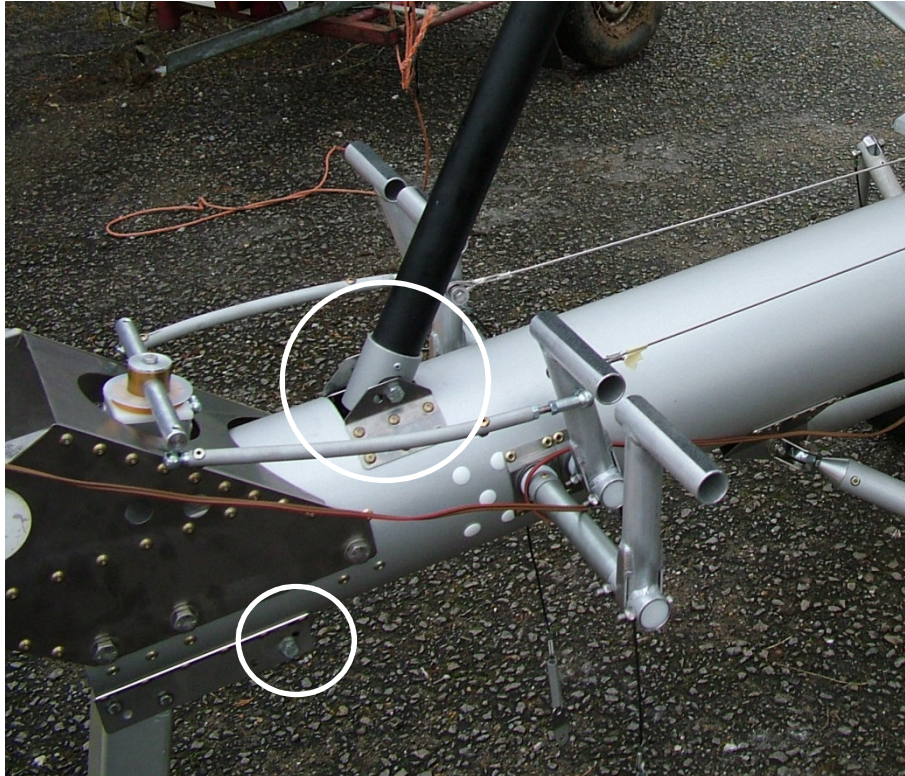
An aircraft with severe cracking of the main fuselage tube emanating from the upper cut-out for the A-strut was also found to have suffered severe cracking of the A-strut around its entire circumference. This was hidden within the outer sleeve positioned at the connection between the A-strut and the upper surface of the main fuselage tube. The load path was maintained by the single small rivet used to locate the outer sleeve on the A-strut. See Figures 1 & 2.

**Figure 1; A-strut attachment to upper surface of main fuselage tube. Lower attachment bolt visible beneath main fuselage tube at aft end of bracket attached to nose leg.**

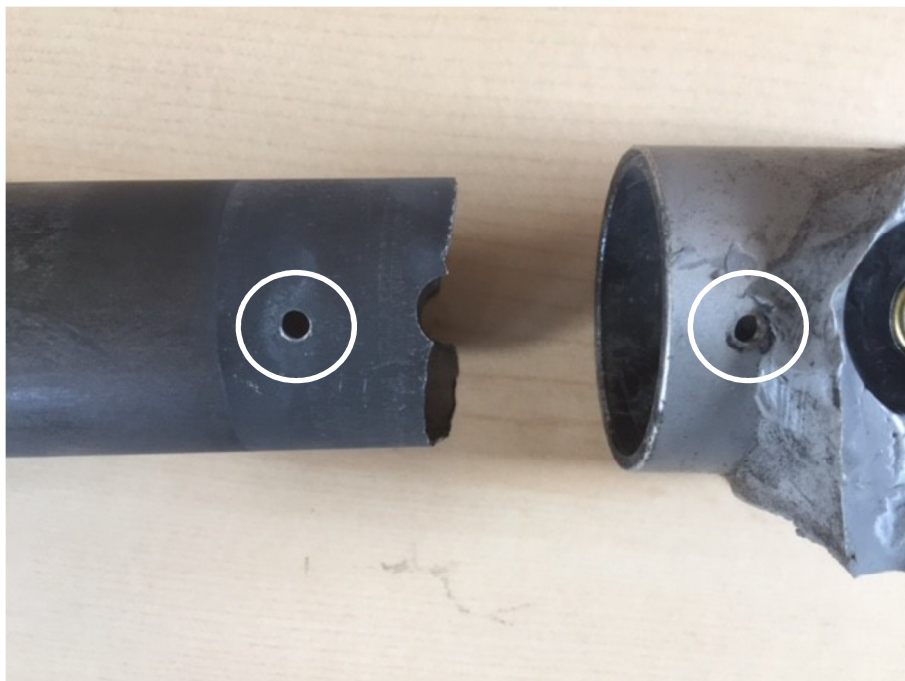
It is believed that the cracking was a result of excessive loads placed upon the A-strut due to the near-failure of the main fuselage tube. One other similar historical case is known to have occurred abroad, on an aircraft known to have suffered landing gear damage.

However, it is also possible that the cracking may also be related to fatigue due to flexing of the A-strut at this point. Therefore inspection on high-hours aircraft is recommended, as well as those which have suffered damage which could have applied excessive loads to the A-strut.

**Figure 2; Failed A-strut removed from outer sleeve part on right of picture. Circled holes show location of the rivet which was holding the parts together.**

We recommend that before next flight the internal surface of the A-strut in the region of the bolt passing through it at the connection to the upper surface of the main fuselage tube is visually inspected for cracks, using a borescope inserted from the lower end.

We recommend that at the next annual or 100hr inspection, whichever comes first, the internal surface of the A-strut in the region of the bolt passing through it at the connection to the upper surface of the main fuselage tube is visually inspected for cracks, using a borescope inserted from the lower end.

If any cracks are found **DO NOT FLY** the aircraft. Please contact [malcolm@red-aviation.com](mailto:malcolm@red-aviation.com) for instructions for fitment of a replacement A-strut.
