## SERVICE BULLETIN INDEX

SB-1	Issue-1	Revised seat harness attachment points
SB-2	Issue-1	Clevis pins with split pins
SB-3	Issue-1	Drain holes in elevator
SB-4	Issue-1	Pitot static tube security
SB-5	Issue-1	Revised fuel filter
SB-6	Issue-1	Exposed terminals
SB-7	Issue-1	Relay supports (sharp corners)
SB-8	Issue-1	Rose joints binding
SB-9	Issue-1	Jury strut clearance
SB-10	Issue-1	Short bolts in critical areas
SB-11	Issue-1	Vapour return system
SB-12	Issue-1	Hinge bolt security
SB-13	Issue-1	Rudder return springs
SB-14	Issue-1	Incorrect screws in critical areas
SB-15	Issue-1	Electrical fuel check valve bypass
SB-16	Issue-1	Elevator horn cracking – factory built
SB-17	Issue-3	Elevator horn cracking – kit built
SB-18	Issue-1	Stub axle cracking
SB-19	Issue-1	Exhaust inspection around cockpit heater jacket
SB-20	Issue-1	Cockpit carbon monoxide detector
SB-21	Issue-1	Seat support tube rotation
SB-22	Issue-1	Incorrect length bolts fitted to cockpit tubes

SB-23	Issue-1	Incorrect length bolts fitted to stub axle
SB-24	Issue-1	Bolts in rudder horn fouling on rear composite
*SB-25	Issue-1	Crack in weld on wing root rib
SB-26	Issue-1	Wing leading edge spar
*SB-27	Issue-1	Engine mount crack

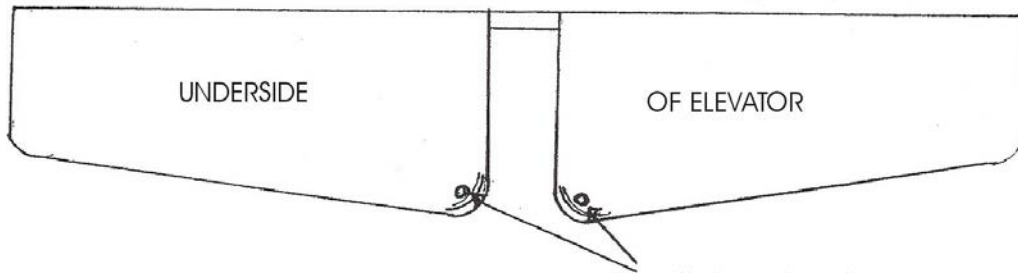
Drain holes just inside  
Inboard of trailing edge tube.

The best method to carry out this modification is to use a small soldering iron with a pencil tip this will produce a small neat hole in the underside of the envelope "sealed" around its edges. Make the hole around 5 to 6 mm on the underside of both elevators as shown, Note; *when making the drain hole take care not to penetrate the upper envelope.*

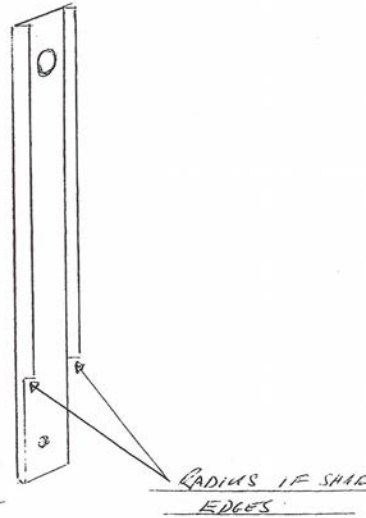
Reason: to eliminate the possibility of cracking

1 If your support stays have sharp corners dress them out using a suitable tool such as a watchmakers round file.

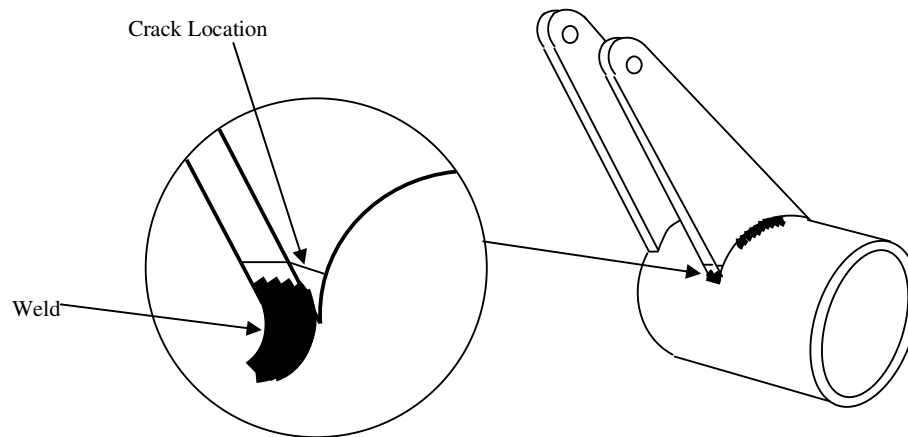
**Nature of Defect** – A short crack has been found on one of the elevator horn plates on a C42 aircraft which had flown 59 hours. The crack appears at the welded junction of the right hand horn plate with the collar tube, at the plate's rear edge, and appears to be associated with a small weld undercut at that point. Drawing 42UKD02.06.00, Issue 26/10/2002, Elevator Horn Assembly, refers.

**Airworthiness Implications** – If the crack propagates through to the adapter tube, this places an increased parting load on the circumferential weld further forward. This in turn may crack. Although the horn consists of two plates, giving some degree of redundancy, the loss of one plate would significantly reduce the safety margin of the elevator control strength.

- (a) Using a dye penetrant crack detection method, inspect the elevator horn for cracks before next flight. Inspect both arms of the horn at all welds. Pay particular attention to the front and rear of the elevator arms at the points where they meet the tube.
- (b) If a crack is found, ground the aircraft and remove the elevator horn assembly. The procedure for this is given below. Replace the part with the modified version having an improved weld pattern; the part is available from Flybuy Ultralights, Part No. 42UKD02.06.00 Issue 10/12/03.

(c) If no crack is found, it is permissible to continue to fly the aircraft for a limited period, but particular attention must be paid to this area during each pre-flight check. In any event the part must be replaced within 90 days of this bulletin by the new assembly having an improved weld pattern.

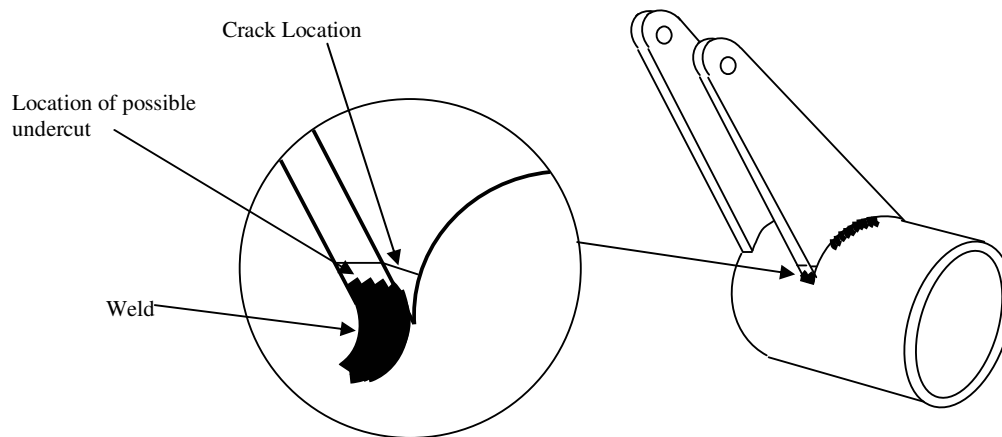
**Nature of Defect** – A short crack has been found on one of the elevator horn plates on a C42 aircraft which had flown 59 hours. The crack appears at the welded junction of the right hand horn plate with the collar tube, at the plate's rear edge, and appears to be associated with a small weld undercut at that point. Drawing 42UKD02.06.00, Issue 26/10/2002, Elevator Horn Assembly, refers.

**Airworthiness Implications** – If the crack propagates through to the adapter tube, this places an increased parting load on the circumferential weld further forward. This in turn may crack. Although the horn consists of two plates, giving some degree of redundancy, the loss of one plate would significantly reduce the safety margin of the elevator control strength.

(a) Using a dye penetrant crack detection method, inspect the elevator horn for cracks before next flight. Inspect both arms of the horn at all welds. Pay particular attention to the front and rear of the elevator arms at the points where they meet the tube.

(b) If a crack is found, ground the aircraft and remove the elevator horn assembly. The procedure for this is given below. Replace the part with the modified version having an improved weld pattern; the part is available from Flybuy Ultralights, Part No. 42UKD02.06.00 Issue 10/12/03

(c) If no crack is found, it is permissible to continue to fly the aircraft for a limited period, but particular attention must be paid to this area during each pre-flight check. In any event the part must be replaced by 5<sup>th</sup> June 2004 by the new assembly having an improved weld pattern.

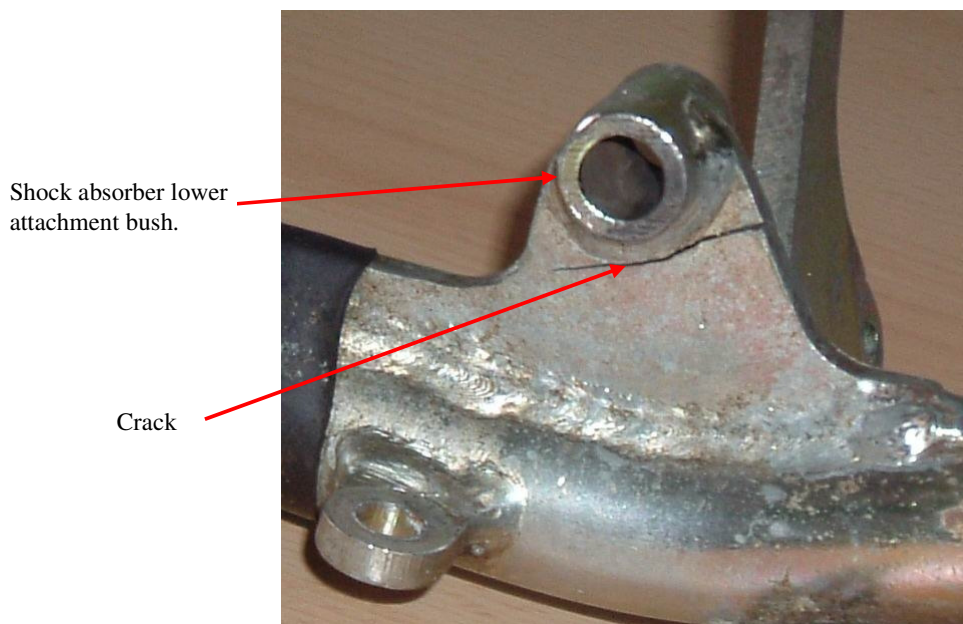
Drawing 42UKA09.02.00, Issue 26/10/2003, Stub Axle Assembly, refers.

**Nature of Defect** – Each steel stub axle of the C 42 (UK) is attached to its shock absorber by a small 6mm thick vertical plate, welded to the stub axle. Almost all the braking torque is reacted by the attachment of this plate to the base of the shock absorber.

Two examples of stub axles on German aircraft, (which have 5mm thick plates), have been found to have cracks near to their junctions with the shock absorber. These are shown below. The German aircraft had completed around 200 hours; number of braked landings is unknown.

**Airworthiness Implications** – If the crack propagates to the inboard side of the lug, then collapse of the undercarriage is likely during the next braked landing.

mounting point for signs of cracking. It may be necessary to jack up the aircraft and remove the lower shock absorber mounting bolt in order to inspect the area properly. Both axles must be checked.

- (b) Have the inspection checked by a BMAA / PFA Inspector and the actions recorded in the aircraft's log book.
- (c) If a crack is found, ground the aircraft and contact Flybuy Ultralights Ltd.
- (d) If no crack is found, it is permissible to continue to fly the aircraft.

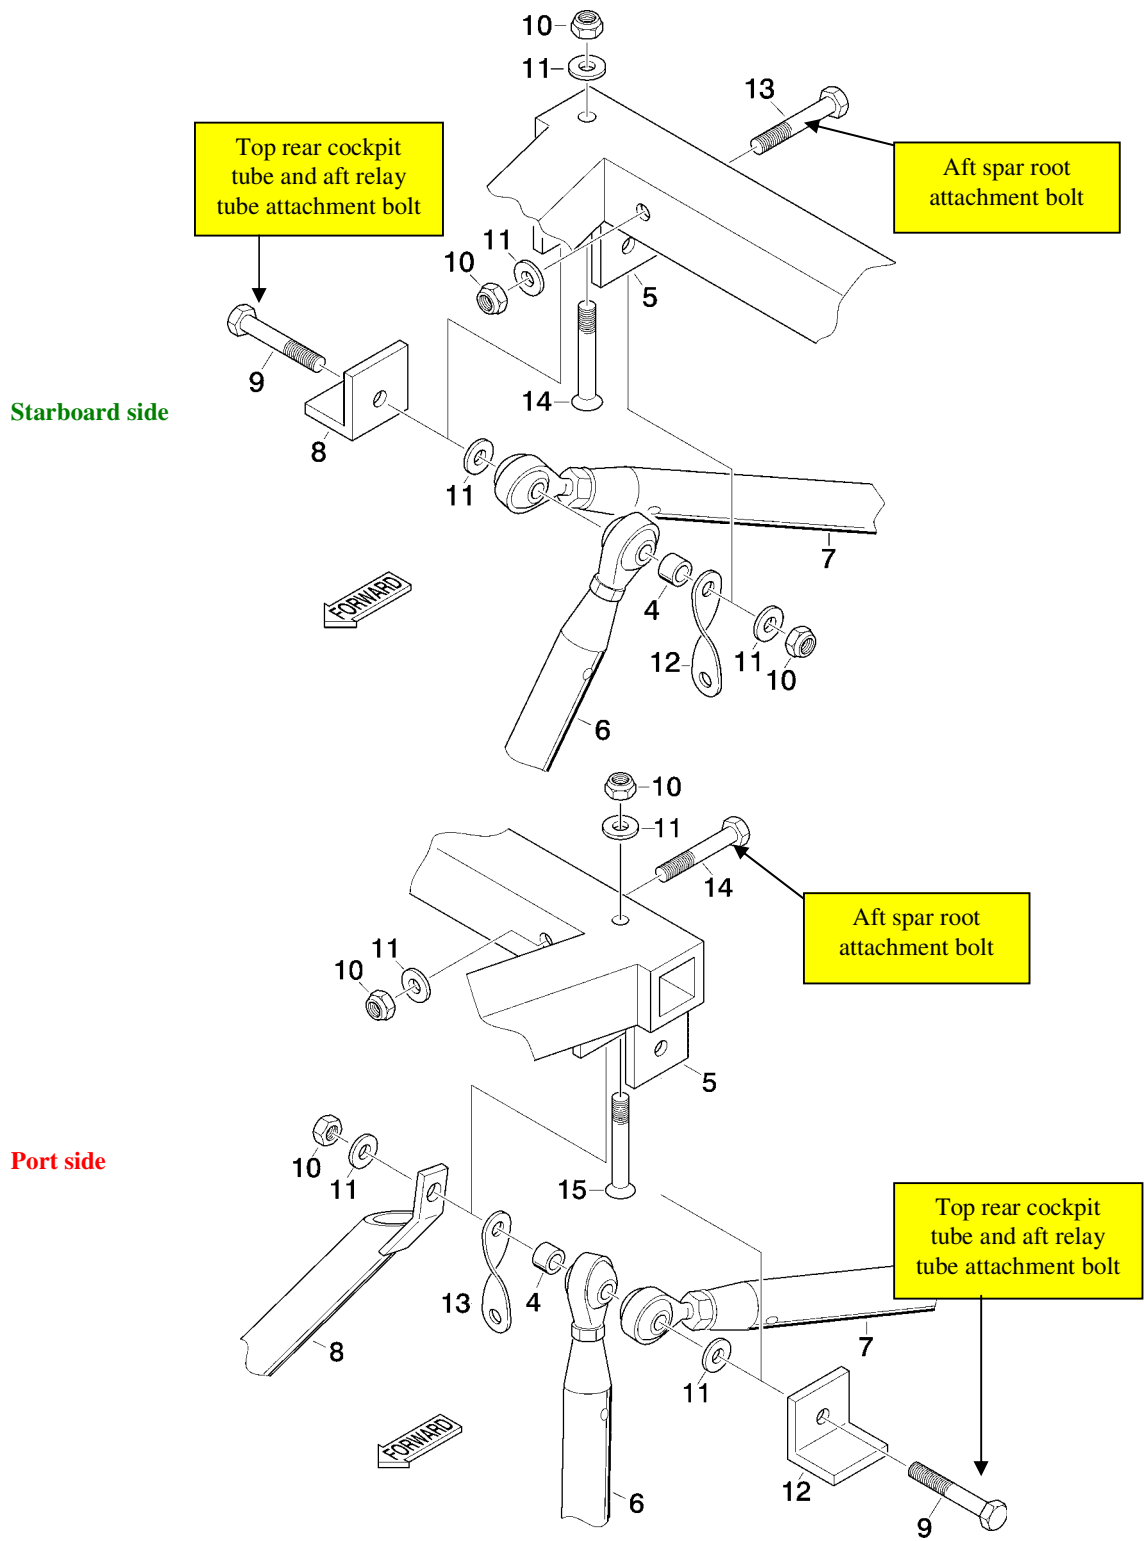
**Nature of Defect** – Possibility of aft spar root attachment bolts and top rear cockpit tube and aft relay tube attachment bolts fitted with load bearing on threaded section of bolt.

**Airworthiness Implications** – Load bearing on threaded section of bolt reduces shear load capabilities of bolt and increases wear on mounting attachment.

- (a) View diagrams on next page which highlight affected bolts.
- (b) Remove nuts and washers (items 10 & 11) from both bolts and check that some shank is visible. If no shank is visible then the bolts must be replaced with correct length bolts.
- (c) Contact Aerosport Ltd for correct bolts and replacement nuts.
- (d) Inspect fittings for signs of wear or fretting from threaded section of bolt. Contact Aerosport Ltd if any wear is detected.
- (e) If the bolt length is acceptable then re-fit washers and fit new nyloc nuts, which are available from Aerosport Ltd. Re-tighten the nuts to a torque of 15Nm.

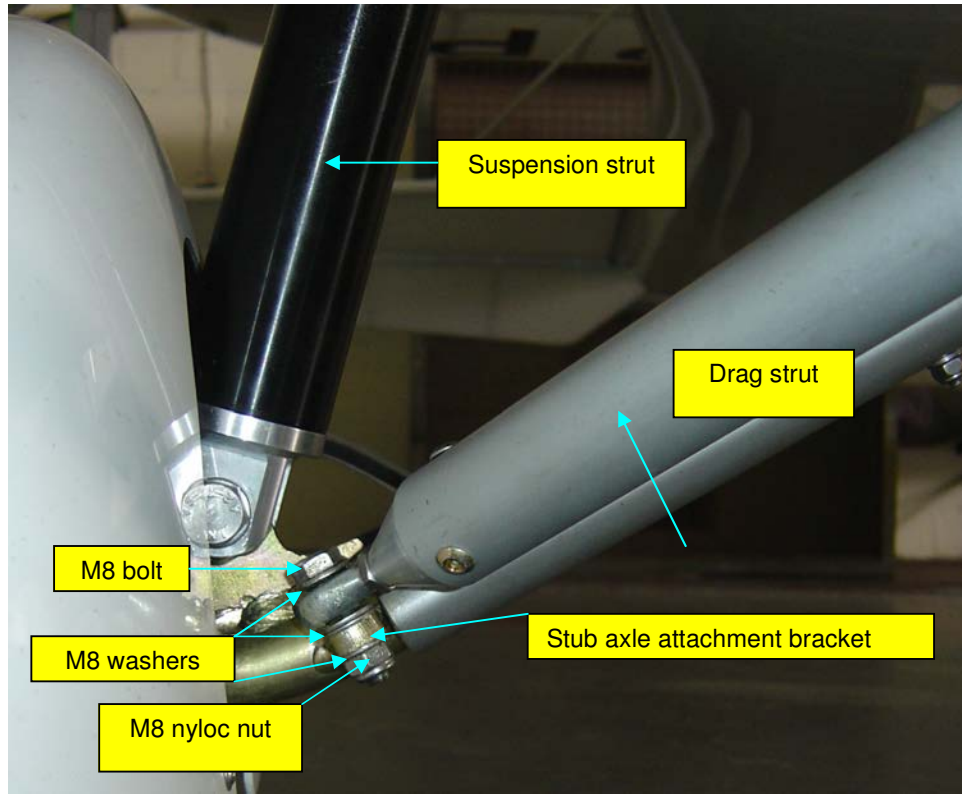
**Nature of Defect** – Possibility of load bearing on threaded section of drag link tube to stub axle connecting bolt.

The bolt passes through a rose joint in the end of the drag link tube, then through an ear welded to the stub axle. Tension and compression loads on the strut result in bending loads being applied to the bolt. If such loads are applied to a threaded portion of the bolt, then bolt cracking, or fatigue failure initiated by the thread roots, are possible.

**Airworthiness Implications** – Bolt failure could result in undercarriage collapse in the event of a hard or fast landing on rough terrain.

- (a) Contact Aerosport Ltd for correct length bolts, additional washers and replacement nyloc nuts.
- (b) View diagram on next page which highlights affected bolt.
- (c) Apply the parking brake. Working on one axle at a time, remove the nyloc nut & washer from the M8 x 40mm bolt shown. Carefully remove the bolt taking care to note the quantity of any washers between the rose joint and stub axle attachment bracket. Re-assemble with the M8 x 50mm bolt, re-fitting the washers in their original position between the rose joint and stub axle attachment bracket. Fit additional washers under the nut, as required, to prevent the nut from becoming thread bound when tightened. Torque to 15Nm.
- (d) Repeat the procedure for the other axle.

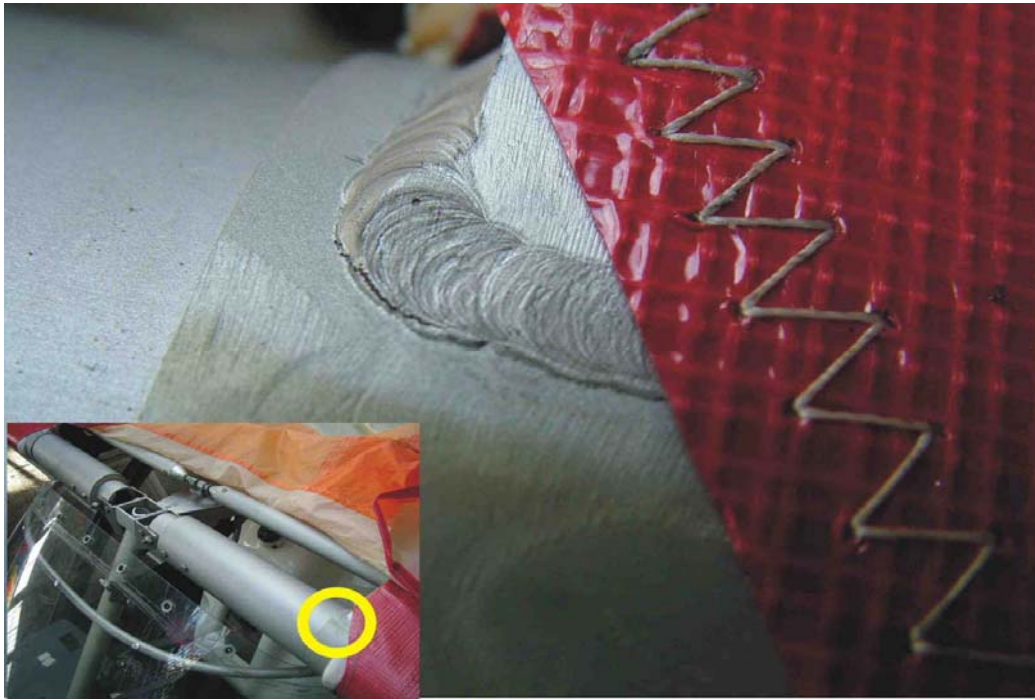
**Nature of Defect** – During an inspection of a C42, a 20mm long crack was discovered where the weld on the wing root rib is attached to the leading edge. The aircraft had completed around 300 hours.

**Airworthiness Implications** – Should the rib fail completely the tension of the wing covering would be lost, resulting in reduced performance of the wing and corresponding loss of roll trim.

It is not clear whether this is a manufacturing fault or fatigue failure, or a combination of both. All aircraft must be checked before the next flight, regardless of hours flown.

1. Remove the roof panel to expose the inboard area of the aluminium root rib where it is welded to the leading and trailing edges.
2. Carefully inspect the weld at this point for cracks. Where any uncertainty exists, use a dye penetrant for crack detection. Protect the screen and surrounding structure from dye spray.
3. If a crack exists, it will be necessary to remove the wing for disassembly. The part must be re-welded by a welder practiced and skilled in aluminium welding, or replaced by an Aerosport-supplied replacement part.
4. Enter the inspection and, if necessary the repair, in the airframe log book. This component is part of the airframe structure and the work must be inspected and signed off by a BMAA or PFA inspector as appropriate before flight.

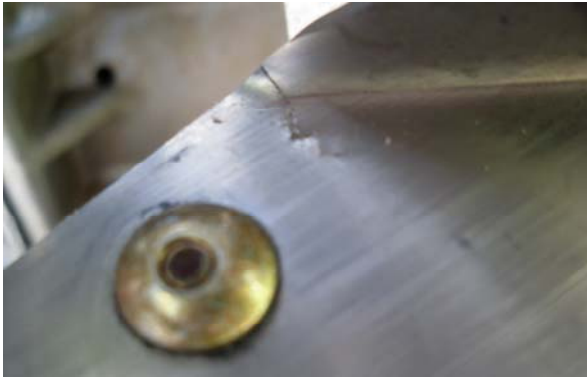
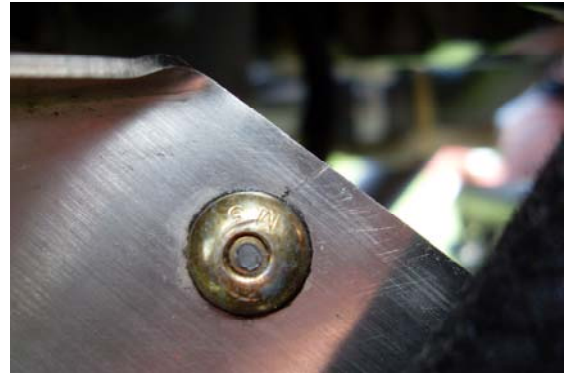
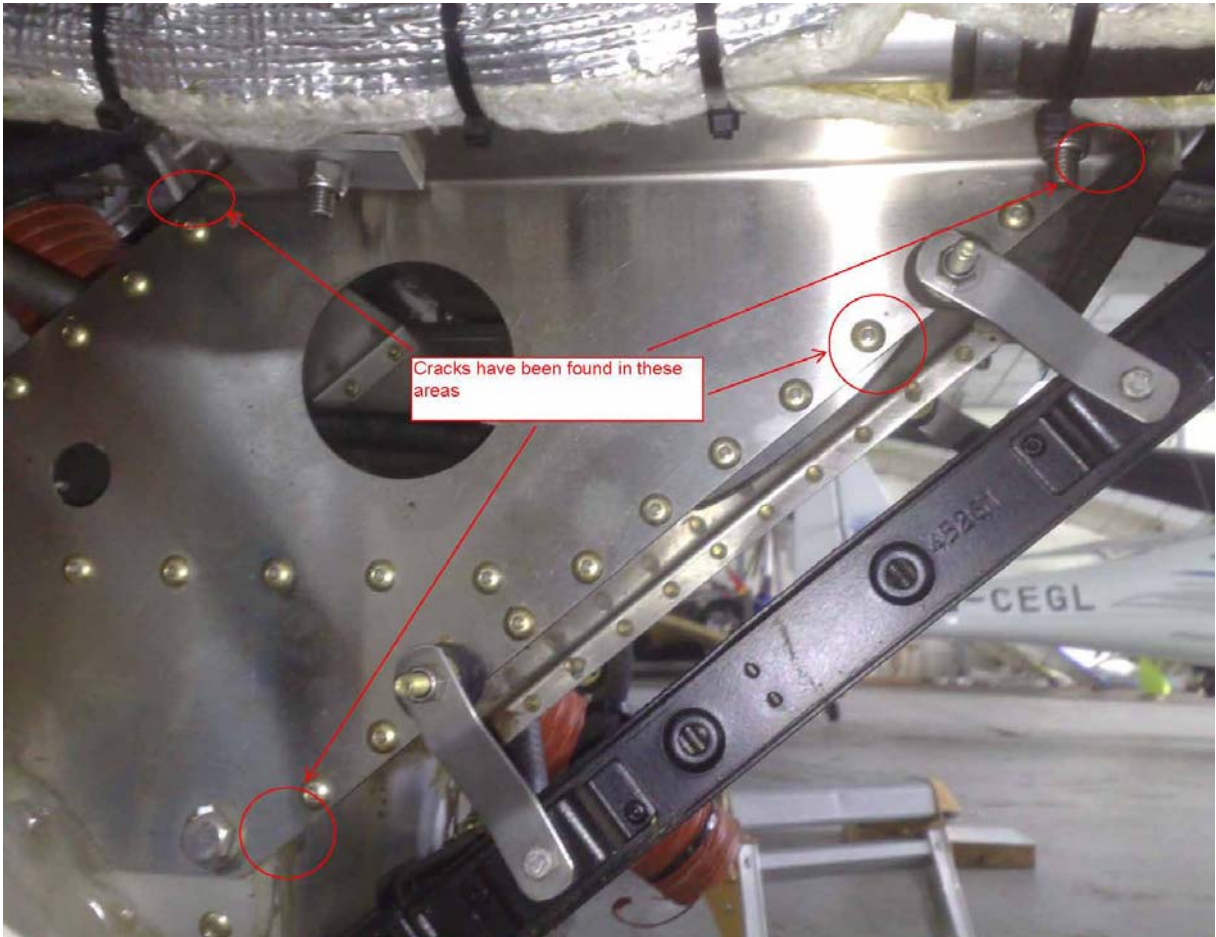
**Nature of Defect** – During an inspection of a C42, a 25mm long crack was discovered in the engine mount side plate starting from the front edge of the mount between the front stiffening plate and the Monobolt attaching it to the main keel tube. The aircraft had completed around 1670 hours.

On another 3 aircraft, short cracks at the top of the mount on the front and rear corners where the plate is bent horizontal and a crack from one of the rivets on the side plate to the front edge have been found.

The cause of the cracking is unproven. However the lower cracks are probably exacerbated by frequent and/or heavy nose impact, or fast taxiing over rough surfaces. Pilots should be aware that nose wheel loads (on any aircraft) should be minimised whenever possible.

4. The inspections must be carried out by a competent person and entered and signed in the airframe log book. If you have any doubts on your abilities to do this inspection, then we suggest you seek advice from your BMAA or LAA inspector as appropriate.

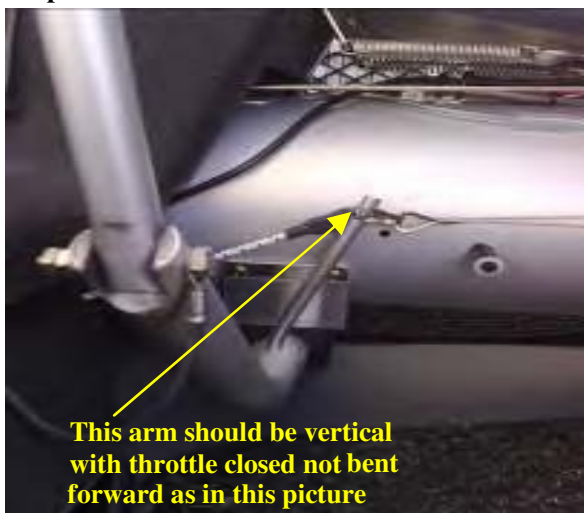
**Picture 1**

**Nature of Defect** – During a training flight a student reported difficulty in closing the throttle. The instructor also found the throttle stiff to close and using greater force than usual in an attempt free the throttle, the arm from the throttle cross tube became bent leaving the engine in the full power setting, even though the throttle lever was now in the closed position. This was caused by the head of the clevis pin on the end of the throttle arm catching on the edge of a hole in the side panel at the full throttle position. Subsequent investigation has shown that if the occupant of the right seat inadvertently pushes on the rearo quvpart of the right hand side panel with their foot or lower leg, then this interference condition with the throttle arm could be reproduced.
