Technical Information Notice

TIN No.:	TIN-01-2018	Revision No.:	1	Issue Date:	01/03/2018
Title:	Owners Service Bulletin – OSB 29 Issue 2				
Applicability:	Ikarus C42 A & B models				
Information Type(s):	MANDATORY				
Modification:		Airworthiness / MPD	✓	Maintenance / Operation	
Parts:		Inspection		Other	
Importance:	ESSENTIAL	✓	HIGH	ROUTINE	✓
<p>Subject Summary / Description of Problem:</p> <p>This notice is up-issued to require both Internal and external inspection:</p> <ul style="list-style-type: none"> The internal inspection of the fuselage tube is by using a borescope, The external visual inspection is also required as experience has shown that cracks cannot be reliably spotted by an internal inspection alone. <p>Instructions on gaining access to the inside of the fuselage tube, and guidance on obtaining and using a borescope, have also been added.</p> <p>Inspection of main fuselage tube for cracking around cut-outs</p> <p>High hours examples of C42 aircraft have exhibited cracks emanating from the corners of the cut-outs in the main fuselage tube where the nose-leg and A-strut are fitted.</p> <p>See example photographs on following pages.</p> <p>Airworthiness Implications<

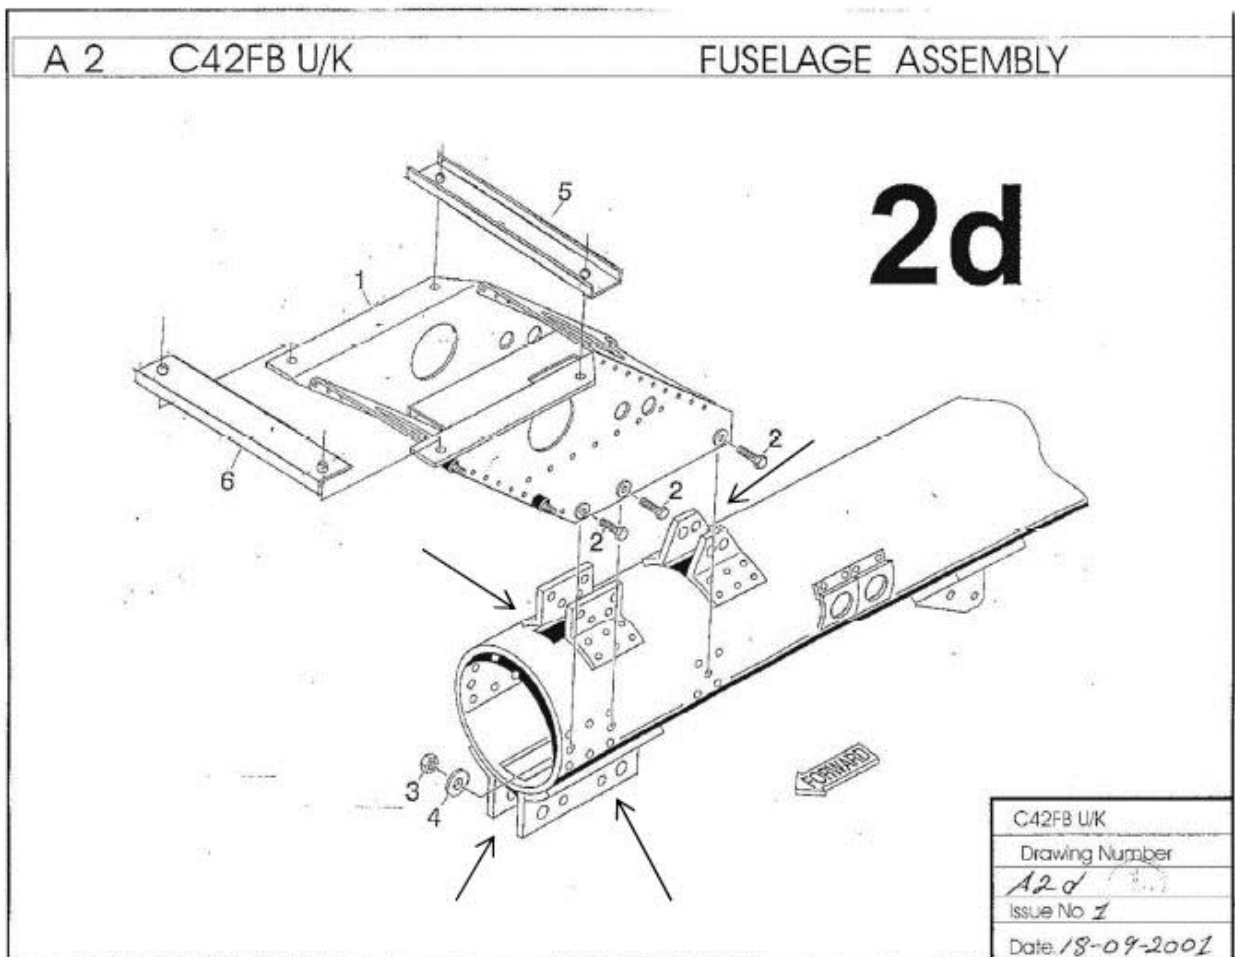
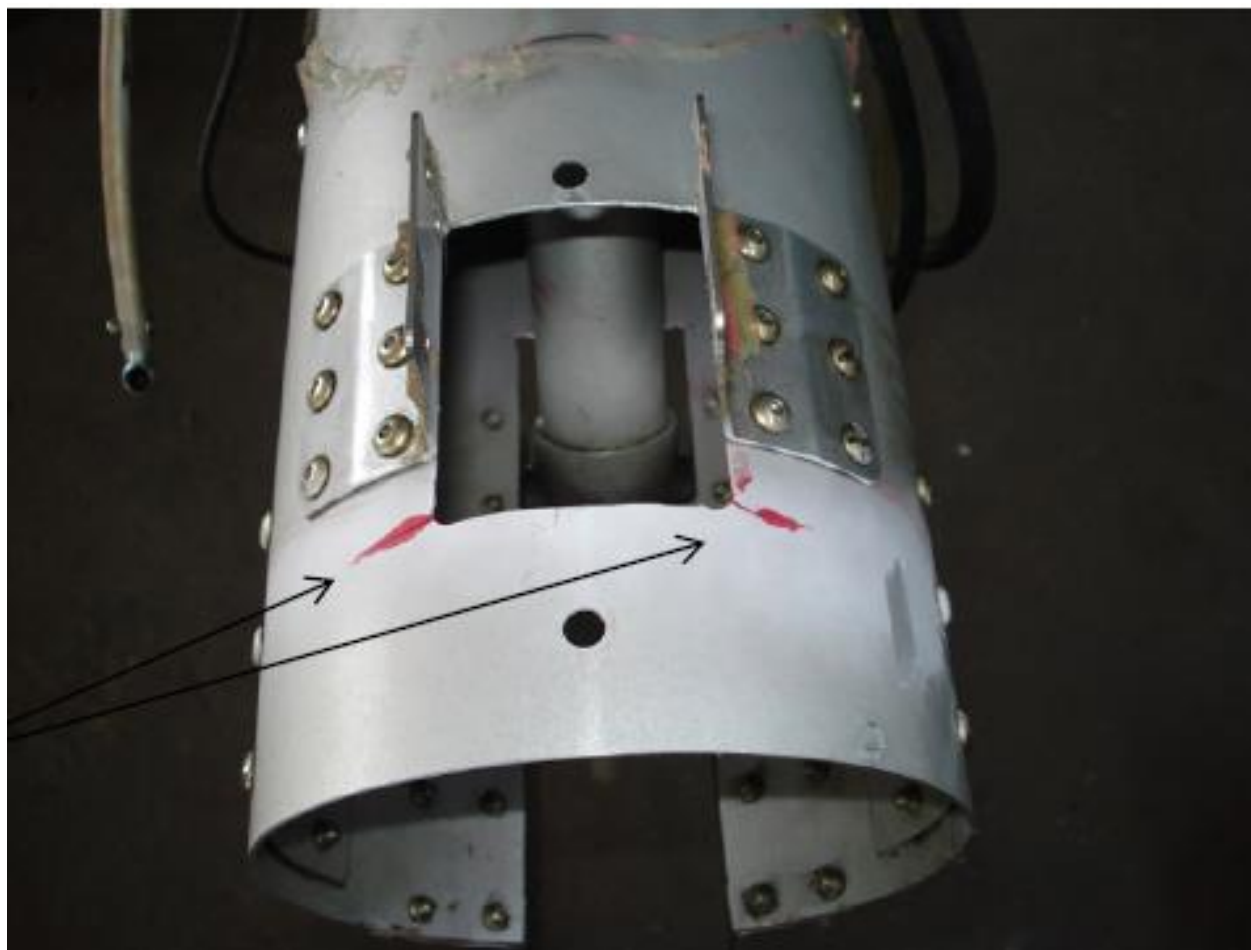
Nose-leg and A-strut cut-outs at front of main fuselage tube in vicinity of engine mount.

- The perimeter of the cut-outs in the main fuselage tube where the nose-leg and A-strut pass through the main fuselage tube must be visually inspected for cracking, with particular attention paid to the corners. Both top and bottom cut-outs must be inspected, 4 cut-outs in total (except on very recent aircraft which have no cut-outs for the A-tube).

- This must be carried out both externally by direct inspection and internally by borescope.
 - In case of doubt, a visual inspection with the aid of dye-penetrant crack detection is recommended.

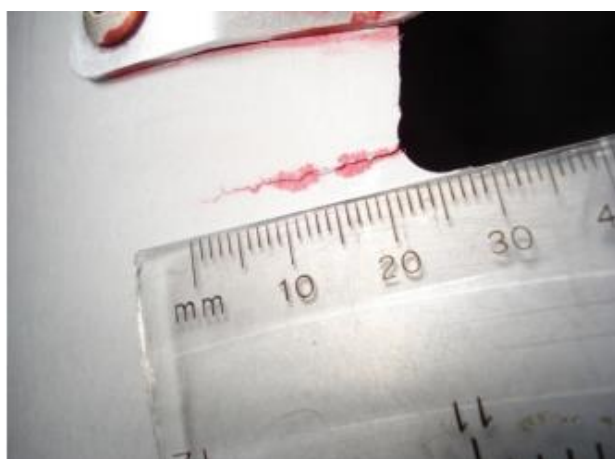
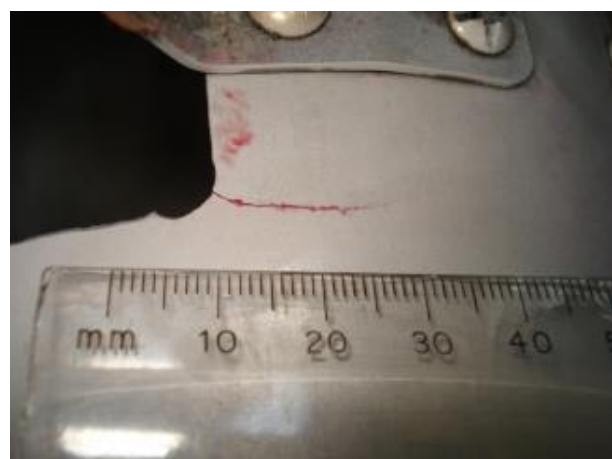
Example cracks on upper surface of main fuselage tube at corners around nose-leg cut-out.

If any cracking is found please contact TLAC. An approved repair scheme involving the fitment of an inner sleeve to the forward end of the main fuselage tube is available.

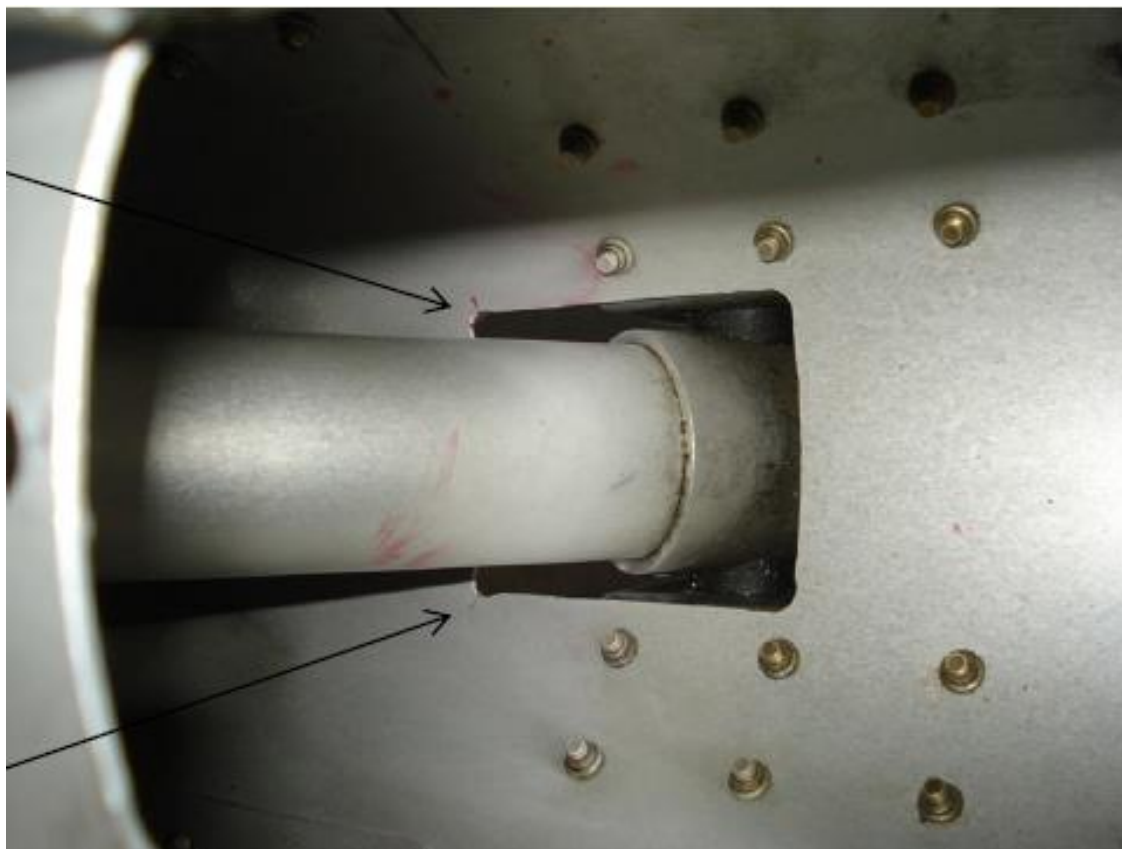
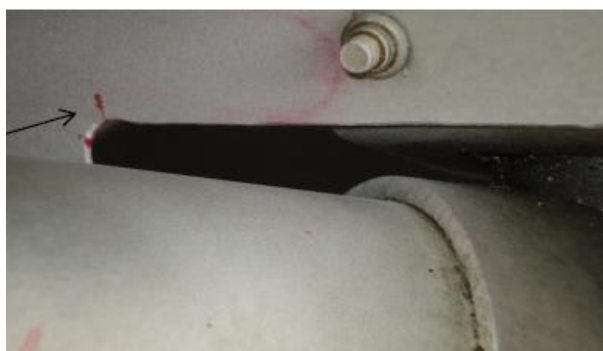
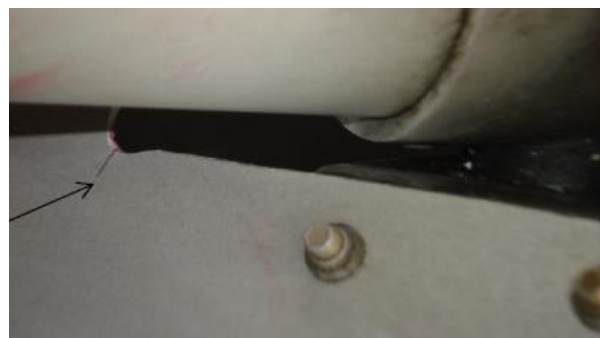
Example cracks on lower surface of main fuselage tube at corners around A-strut cut-out.

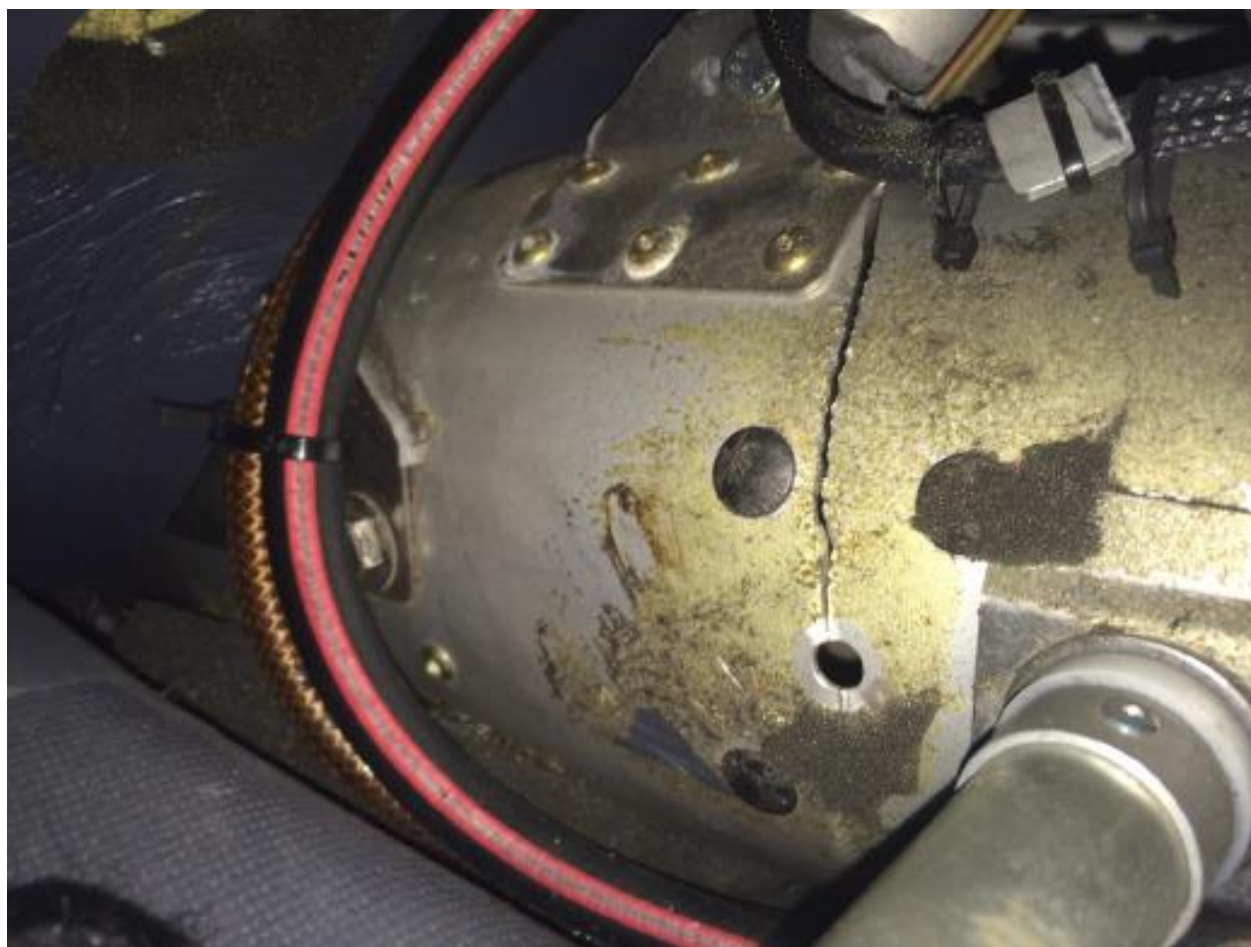
Figure 8

Example of significant crack allowed to propagate on 4500hr aircraft. This crack was hidden by the firewall sound-deadening foam. Ensure that it is removed for inspection.

- Remove the upper and lower engine cowlings, and lower fuselage fairing. Consult the builders manual for detailed instructions.
 - Remove the area of sound-deadening foam on the cockpit side of the firewall which hinders inspection of the A-strut cut-out just forward of the rudder pedals on the top of the main fuselage tube. This is the area which concealed the significant crack shown in the example photographs above.

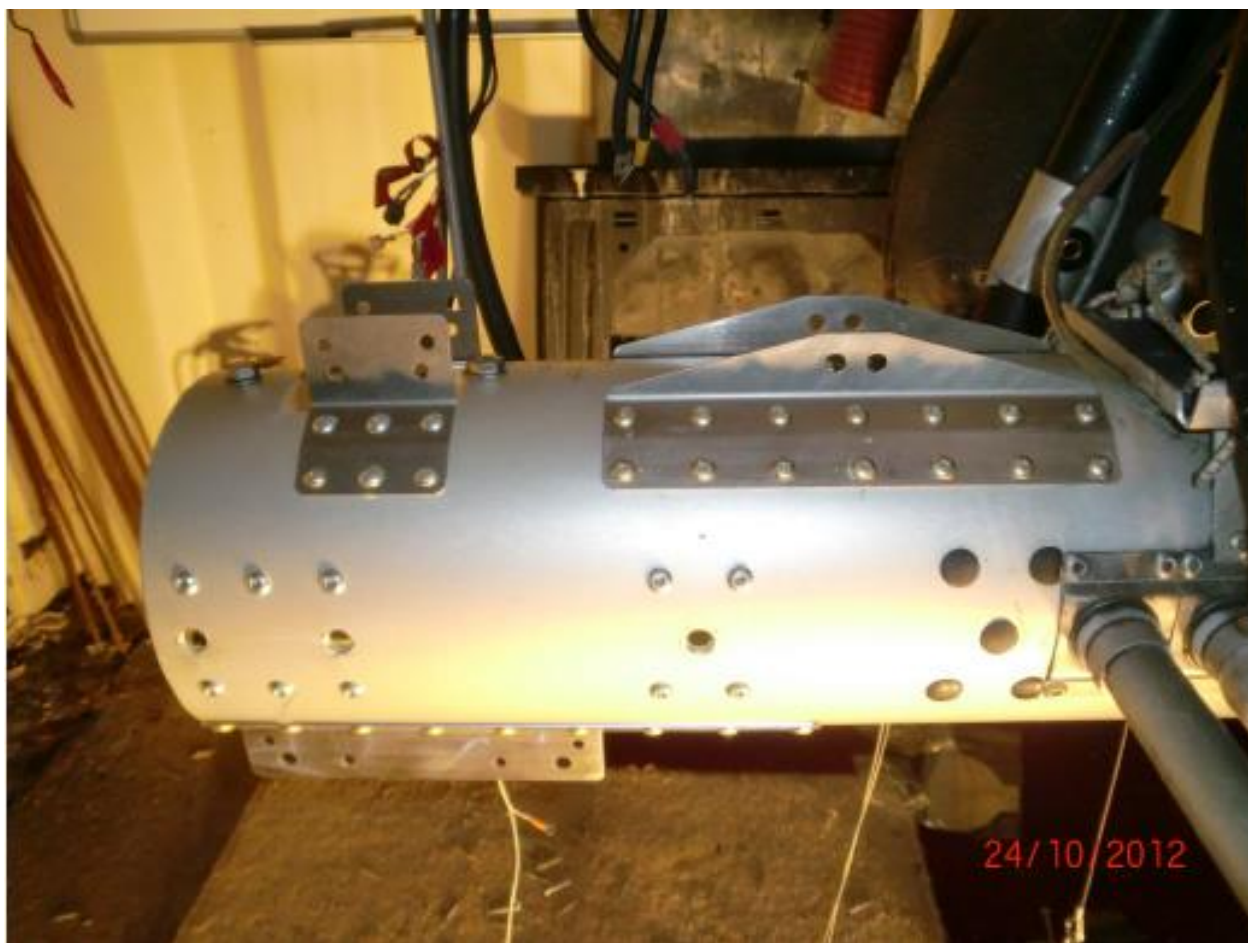
Figure 9

1. The stainless steel brackets securing the A-strut to the top side of the fuselage tube (the rear most brackets) were lengthened in around 2007, see Figure 9.
2. The holes for the A-strut attachment, (the rearmost set of holes, one in the top of the main fuselage tube, one in the bottom), were eliminated entirely around 2015.

Lengthened A-strut top attachment brackets as found on aircraft from around 2007.
