## Technical Information Notice

TIN No.:	<b>TIN-02-2018</b>	Revision No.:	<b>1</b>	Issue Date:	<b>01/03/2018</b>
Title:	<b>Owners Service Bulletin – OSB 31 Issue 2</b>				
Applicability:	<b>Ikarus C42A &amp; B models with A-strut passing through main fuselage tube</b>				
Information Type(s):	<b>MANDATORY</b>				
Modification:		Airworthiness / MPD	✓	Maintenance / Operation	
Parts:		Inspection		Other	
Importance:	<b>ESSENTIAL</b>	✓	<b>HIGH</b>	<b>ROUTINE</b>	✓
Subject Summary / Description of Problem:					
<p>An aircraft with severe cracking of the main fuselage tube emanating from the upper cut-out for the A-strut was also found to have suffered severe cracking of the A-strut around its entire circumference, this is no longer an isolated occurrence after three have now been found in the UK, they have all been high hours (circa 4000) but not all involved in an accident.</p> <p>This was hidden within the outer sleeve positioned at the connection between the A-strut and the upper surface of the main fuselage tube. The load path was maintained by the single small rivet used to locate the outer sleeve on the A-strut. See Figures 1 &amp; 2.</p> <p>It is believed that the cracking was a

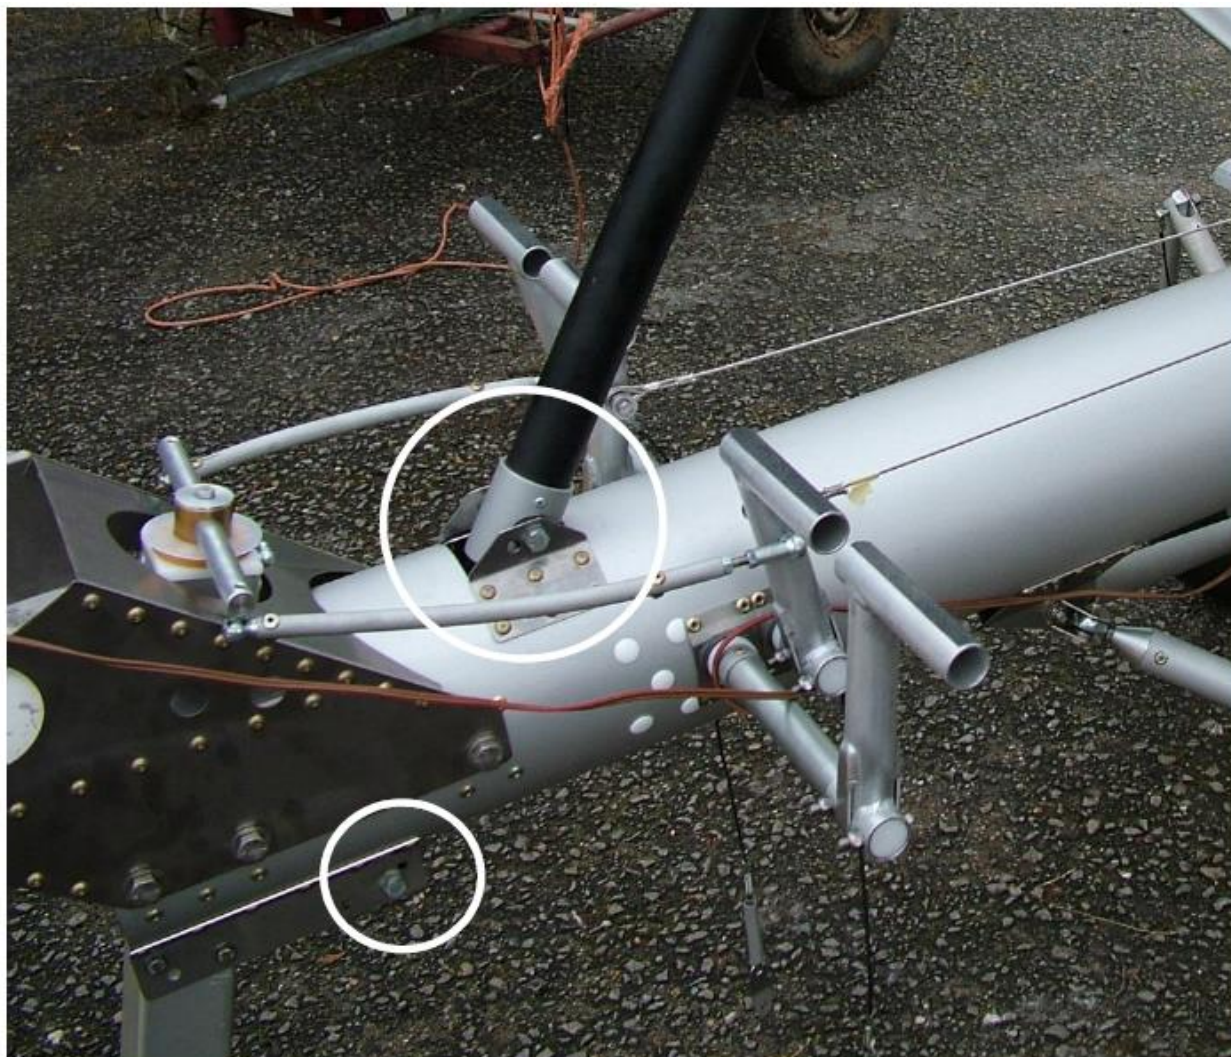
**Figure 1** - A-strut attachment to upper surface of main fuselage tube. Lower attachment bolt visible beneath main fuselage tube at aft end of bracket attached to nose leg

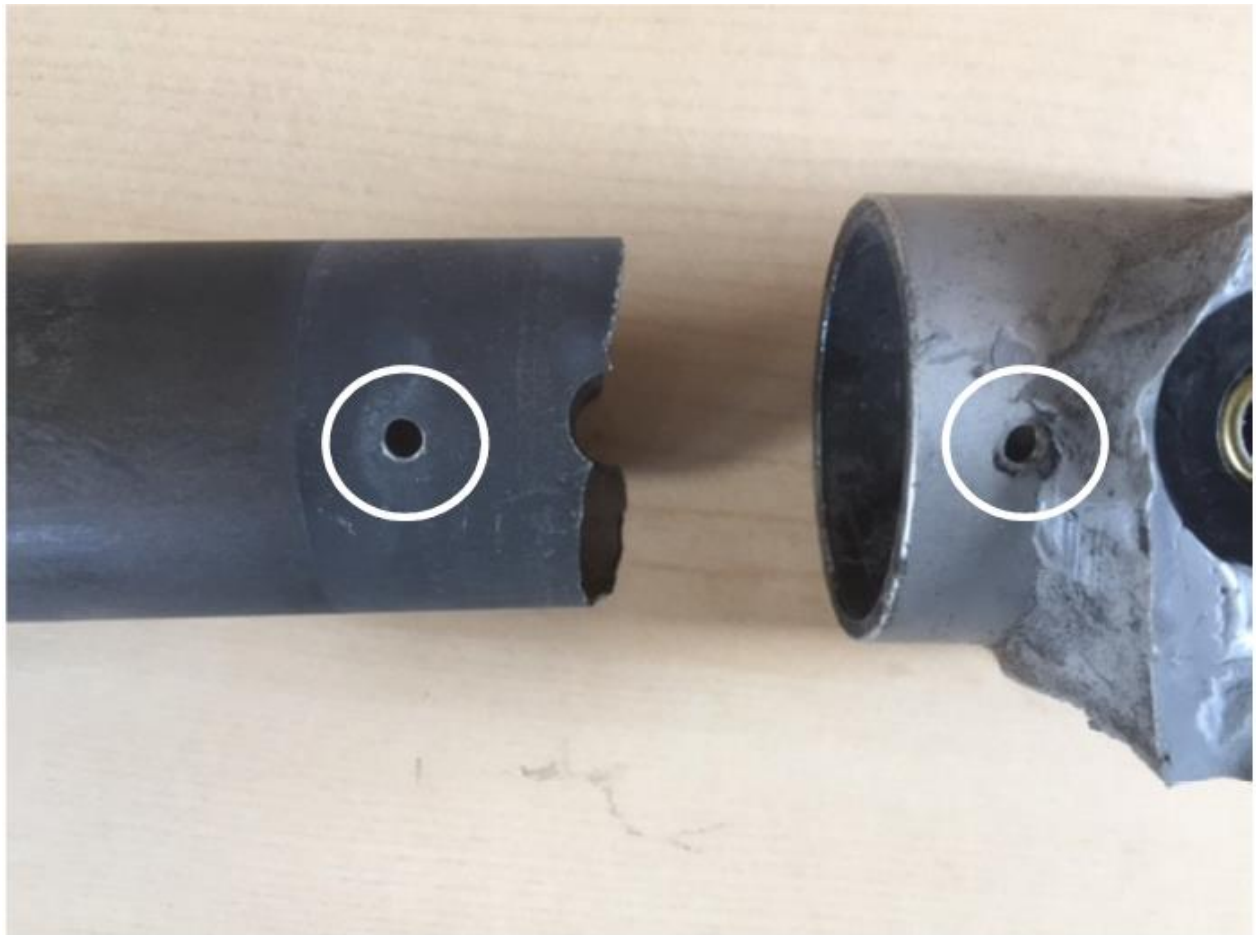
**Figure 2** - Failed A-strut removed from outer sleeve part on right of picture. Circled holes show location of the rivet which was holding the parts together.

If such cracks are allowed to propagate the structural integrity of the A-strut will be compromised.

The aircraft exhibiting the cracked A-strut had in excess of 4000 hours of operation and had suffered damage to the main fuselage tube (reference TLAC TIN-01-2018 OSB-29 Main Fuselage Tube Cracking).

- Record the inspection in the aircraft logbook.
- Amend the Pilot's Operating Handbook, 100hr/annual inspection schedule to include this inspection.
- If any cracks are found DO NOT FLY the aircraft. Please contact sales@g-tlac.com for instructions for fitment of a replacement A-strut.

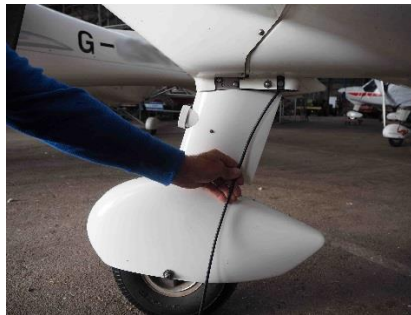
**Figure 4** - endoscope in operation

Figure 4 shows an endoscope being used to inspect a C42 front strut. The area of interest is approximately 200mm up the front strut.

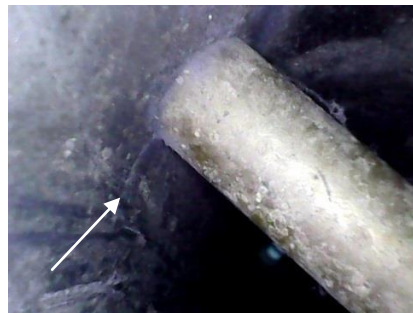
**Figure 5** - photograph of crack emanating from side of hole taken with a USB endoscope

Figure 5 shows a crack emanating from the side of the bushed hole.
