Technical Information Notice

TIN No.:	TIN-03-2018	Revision No.:	1	Issue Date:	22/02/2019
Title:	Owners Service Bulletin – OSB 32 Issue 1				
Applicability:	Ikarus C42 A models only				
Information Type(s):	MANDATORY				
Modification:		Airworthiness / MPD	<input checked="" type="checkbox"/>	Maintenance / Operation	
Parts:		Inspection		Other	
Importance:	ESSENTIAL	<input checked="" type="checkbox"/>	HIGH	ROUTINE	
<p>Subject Summary / Description of Problem:</p> <p>Inspection of nosewheel steering pushrods for abrasion damage due to contact with cabin heater air intake hose</p> <p>A number of high hours examples of C42 A-model aircraft have been found to have suffered severe abrasion damage to the port side nosewheel steering pushrod, and occasionally also the starboard side nosewheel steering pushrod.</p> <p>The damage is caused by contact with the cabin heater air intake SCAT hose, where it runs from the intake on the lower cowl port side up to the heat exchanger jacket around the exhaust.</p> <p>The damage is hidden by the firewall “boot” which seals the pushrod opening in the firewall, compounded by the presence of the SCAT hose itself and the oil tank adjacent to it on the firew

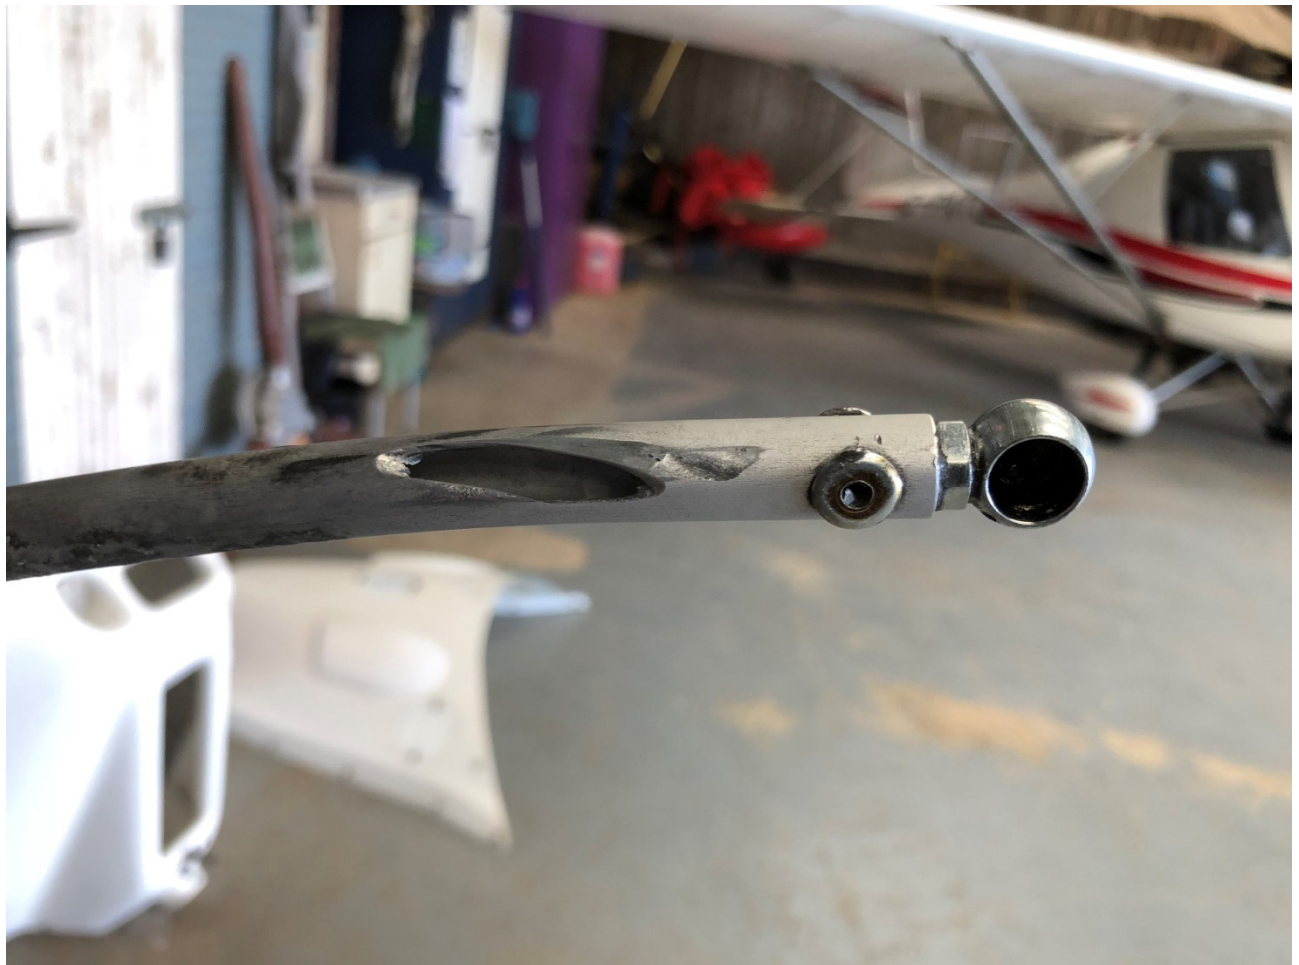
Figure 1, severely abraded port-side nosewheel steering pushrod.

If the pushrod is damaged it must be replaced.

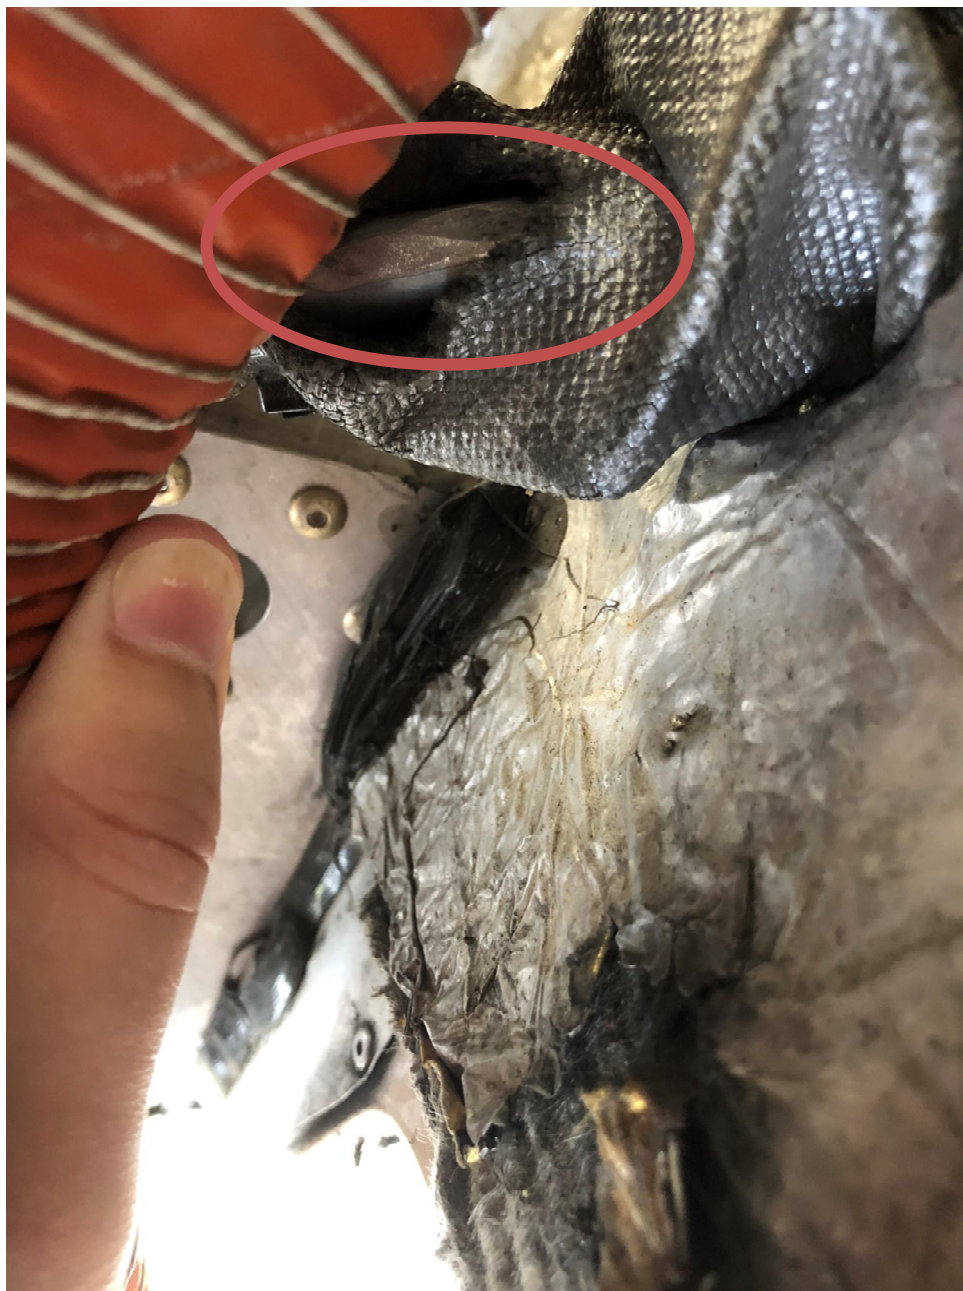
Figure 2, abrasion visible through damaged firewall boot by moving SCAT hose.

Restore the firewall boot to its original position, and replace any tie-wraps which were cut off the SCAT hose. Ensure the SCAT hose is secured in a position where it does not cause further damage. It may be necessary to slightly shorten the SCAT hose to allow it to take up a better position clear of the pushrods.

If the firewall boot is damaged it must be replaced.

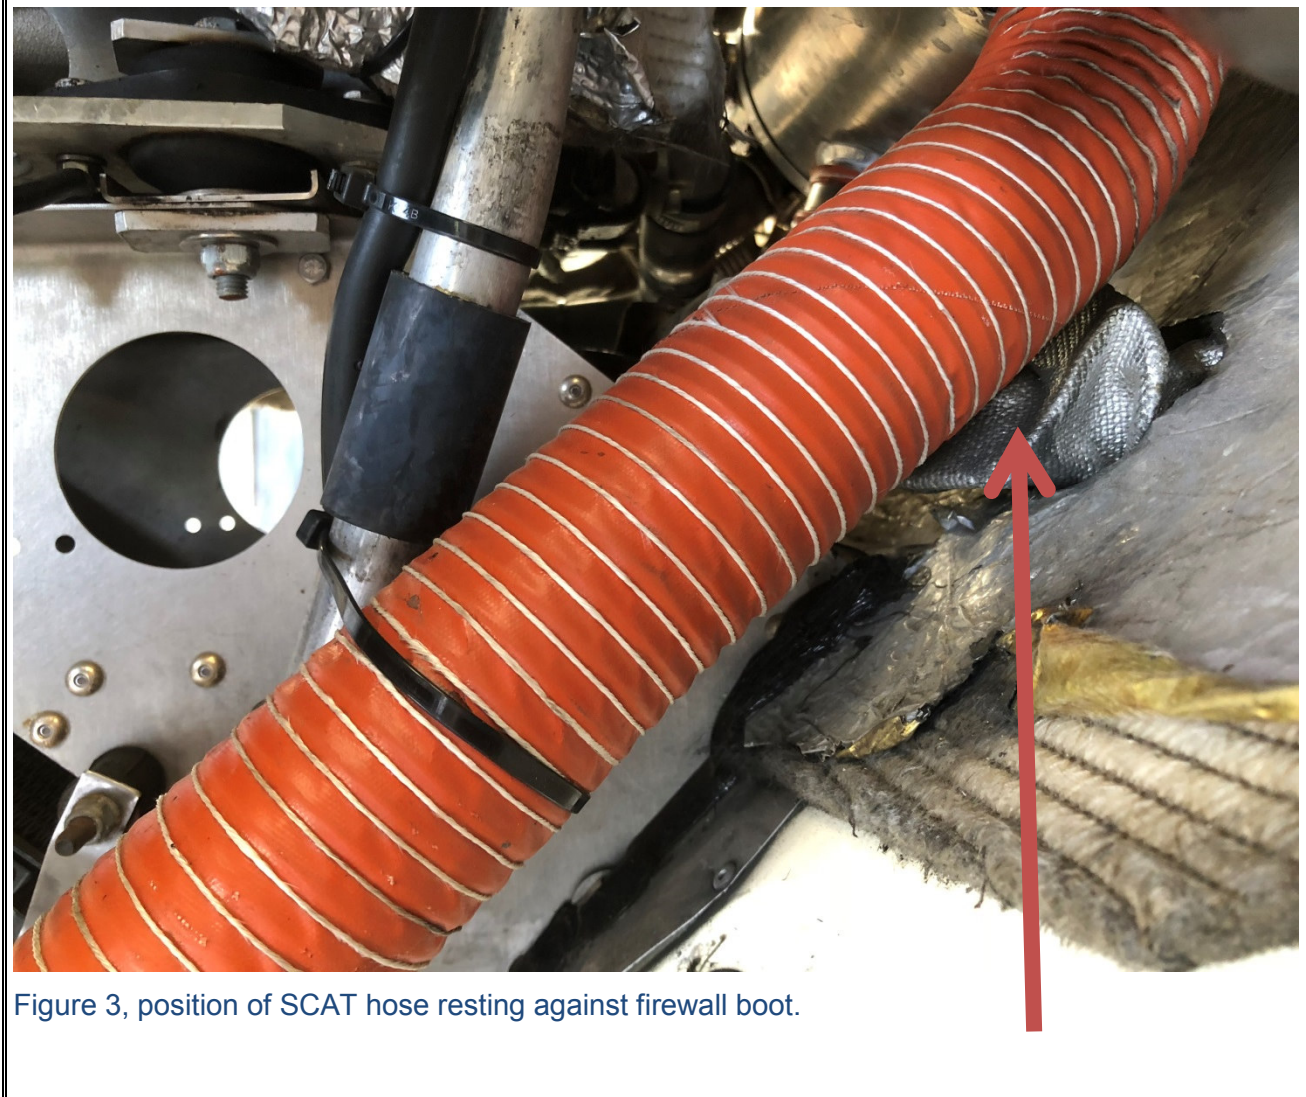
Figure 3, position of SCAT hose resting against firewall boot.
