D-Motor International bvba

Service Bulletin NO. 2019-014/2

SUBJECT : Alternator Flywheel modifications (improvements) Version 2

MODELS AFFECTED : All models on LF26 and LF39 engines**TIME OF COMPLIANCE :** from 11/06/2019, or when due to service**AFFECTED SERIAL NUMBER(S) :** See (*)**Scope :**

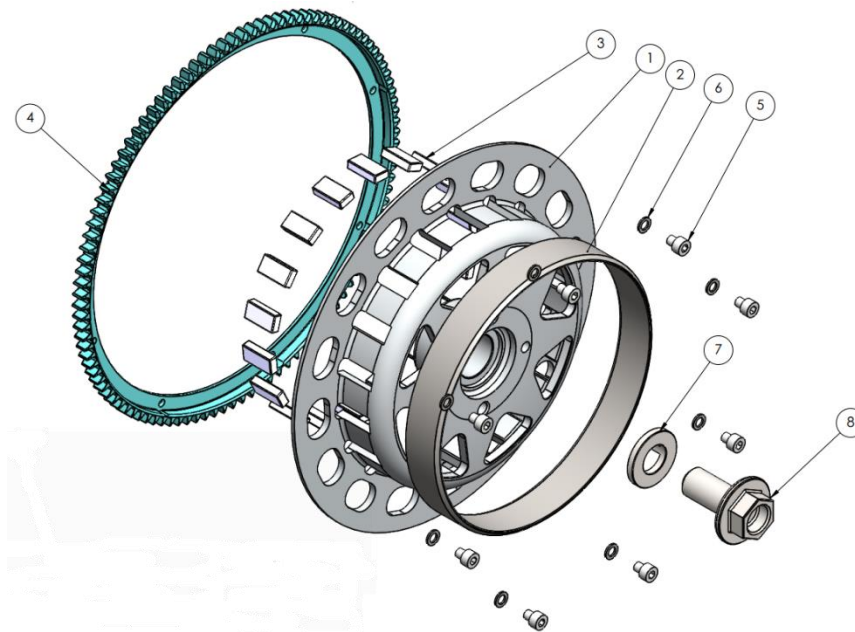
The FlyWheel (alternator) structure was modified (structure). the new model is stronger and more resistant to large forces. The fixation was changed. (new special washer added)

The openings on the Flywheel are triangular now, instead of trapezoidal.
The body is thicker.

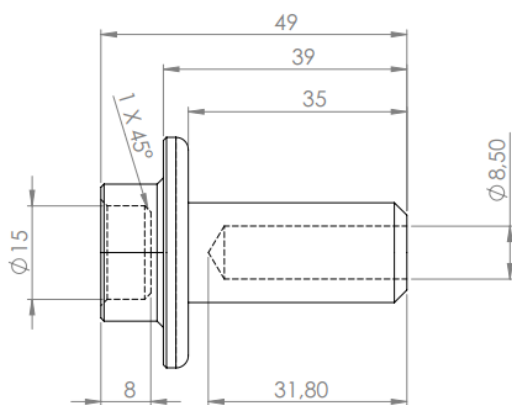
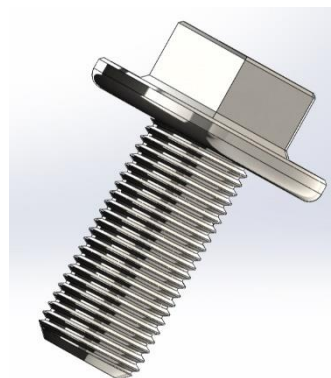
Bolt structure (fixation bolt)

(*) M16X1.25 / M16X1.5 Bolt

Depending on the Serial number of the Cranckshaft, the bolt dimensions are

If S/N starts with 'FAR' the Bolt to use is M16X1.25

If S/N is NOT FAR, the bolt to use is M16X1.5

Bolt tension : 110 Nm – in case of doubt, contact our technical department

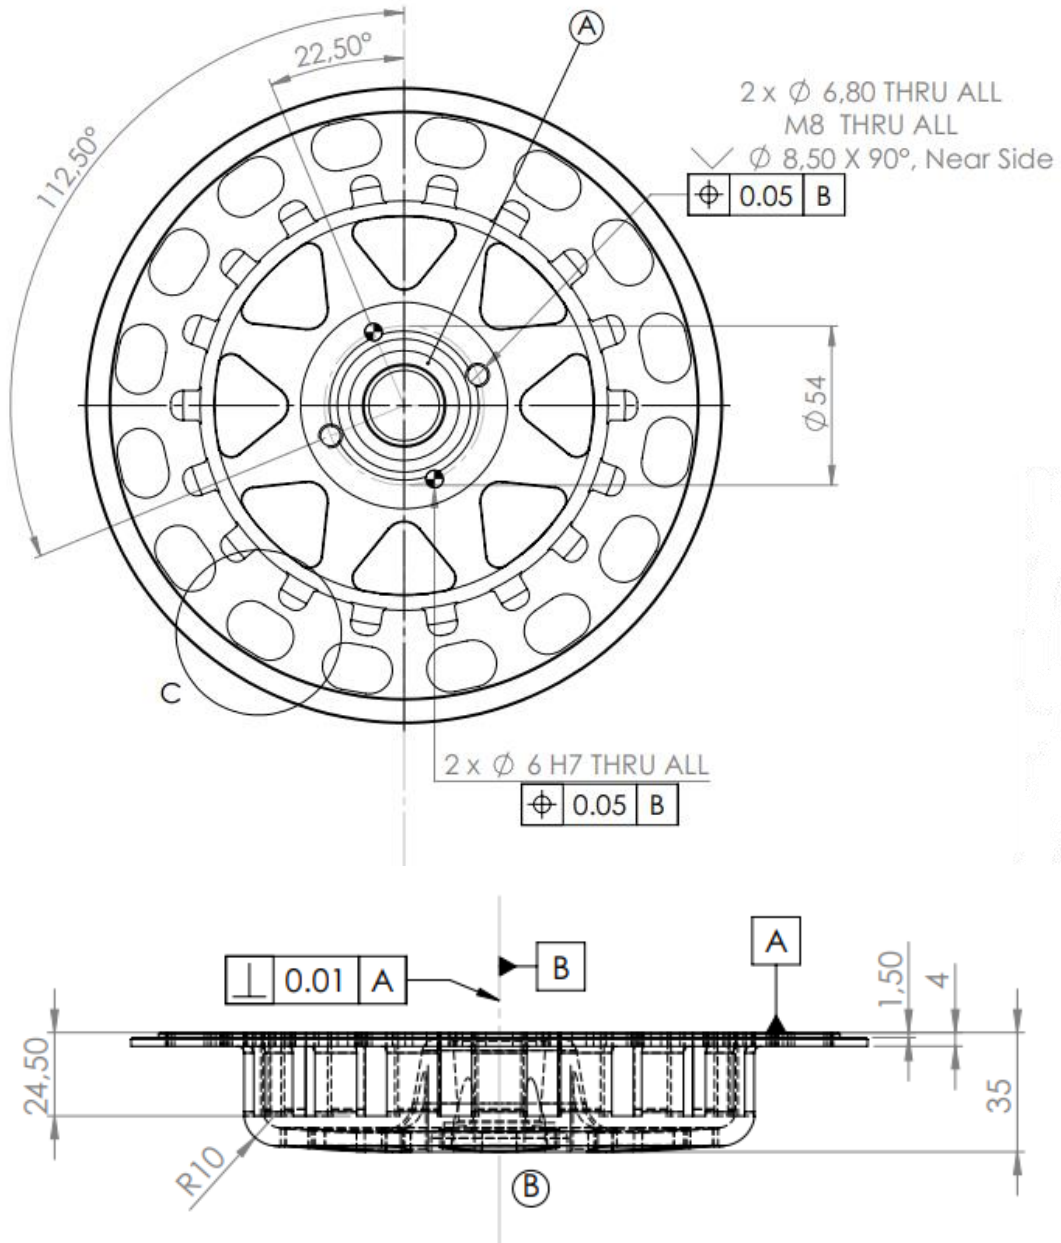
REVISIONS				
ZONE	REV.	DESCRIPTION	DATE	APPROVED
E6	A	Front face of cone is brought back with 2mm	11/03/2019	PDE
A7	B	chamber of Ø32.5 with a depth of 2.5mm is added	11/06/2019	PDE

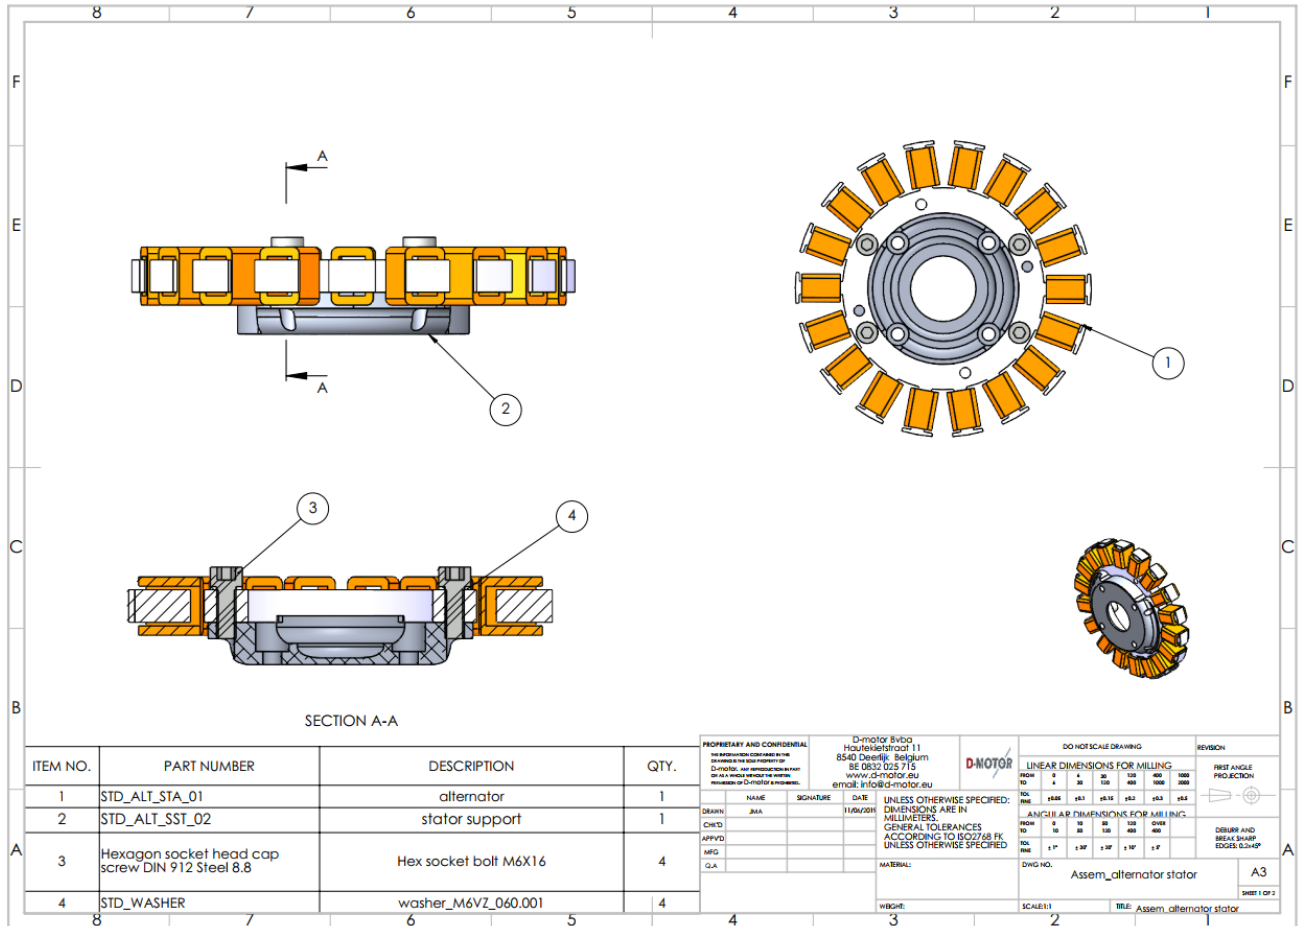
Alternator Stator (fixation plate to be changed) :

- >> The flywheel structure is thicker, the fixation plate Coil ↔ Backplate is thicker
- >> The cabling that enters the coil set should change side !!! (in order to prevent damage to the cabling set)

CAUTION : The Stator plate has changed as well !

Do not use the 'old' stator plate
