Technical Information Notice

TIN No.:	TIN-04-2020	Revision No.:	1.0	Issue Date:	11/03/2020
Title:	Owners Service Bulletin – OSB 33 Issue 1.0 Control Surface Corrosion and Cracking				
Applicability:	Ikarus C42 all models				
Information Type(s):	MANDATORY				
Modification:		Airworthiness / MPD	✓	Maintenance / Operation	
Parts:		Inspection		Other	
Importance:	ESSENTIAL	✓	HIGH	ROUTINE	
<p>Subject Summary / Description of Problem:</p> <p>Inspection of control surface hinge and horn attachments for corrosion or cracking of aluminium tubes.</p> <p>A number of high hours examples and/or those kept outside (particularly near the coast) of C42 aircraft have been found to have suffered corrosion of the control surface front spar tubes where the eyebolt hinges and, in the case of the aileron, where the aileron horn are attached.</p> <p>The corrosion is related to the dissimilar metals in contact at these positions combined with moisture, and may be exacerbated by salt-laden coastal air.</p> <p>In addition, localised cracking around the eyebolt hinge attachments has been noted where the eyebolt has been overtightened with resulting deformation of the aluminium tube. This may also be exacerba

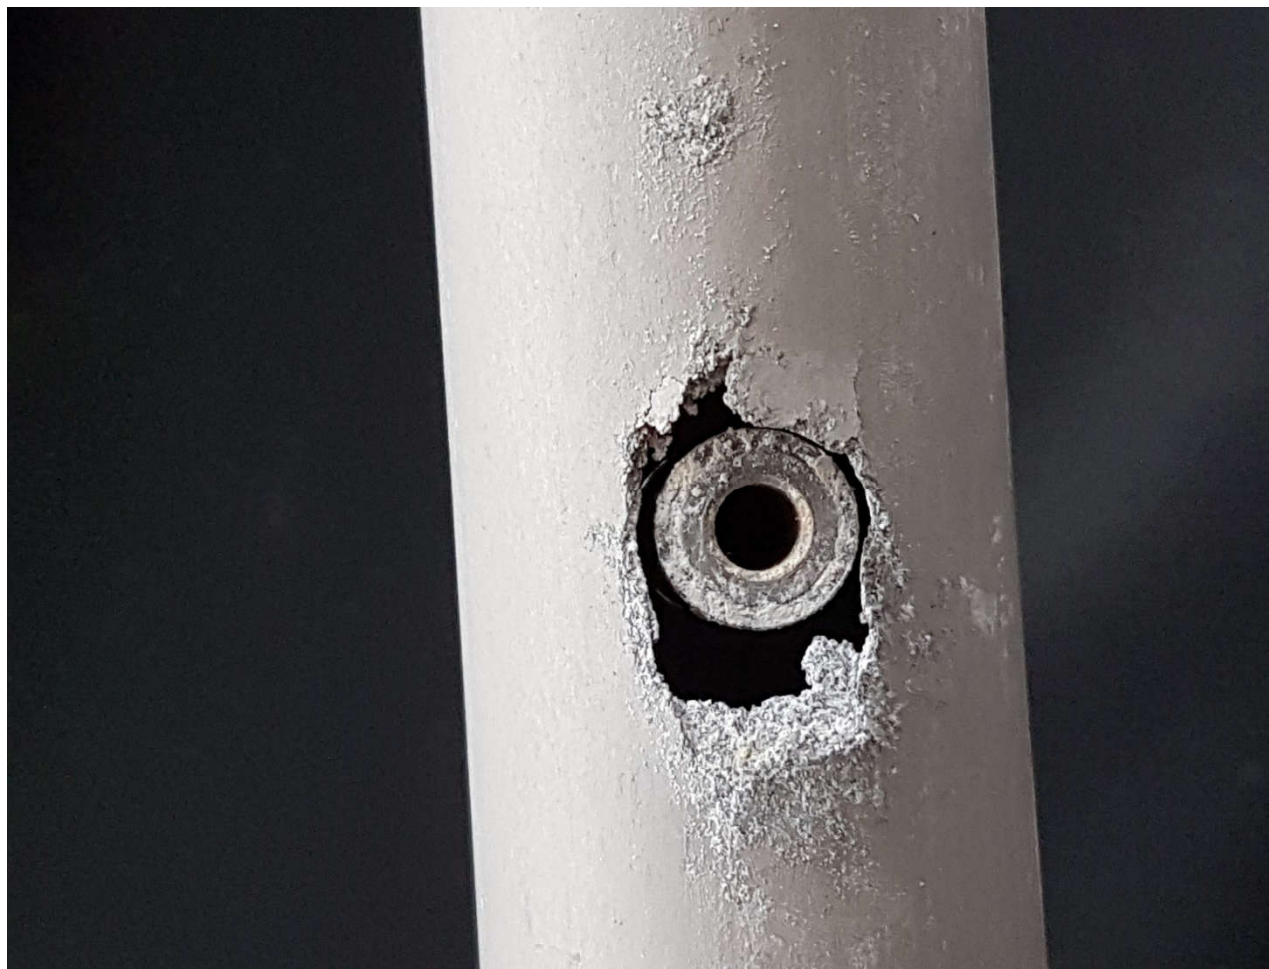
Figure 1, severely corroded aileron centre eyebolt hinge attachment point (hidden under fabric covering in service).

If any of the tubes are corroded or cracked they must be replaced.

Contact TLAC for parts and instructions.

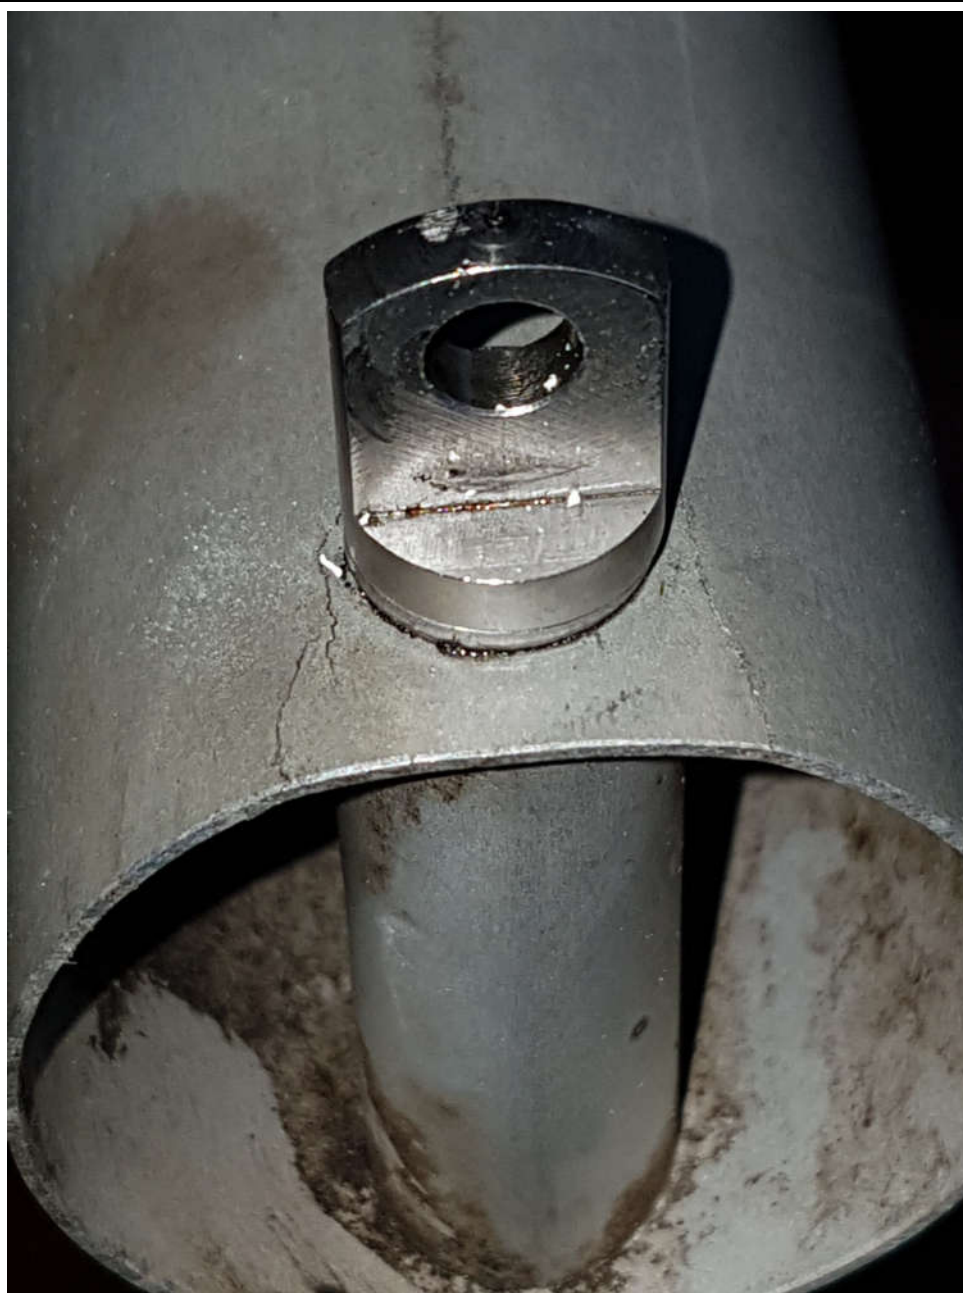
Figure 2, cracked aileron inboard eyebolt attachment, caused by overtightening eyebolt onto flat ended insert (not hidden by fabric covering in service).

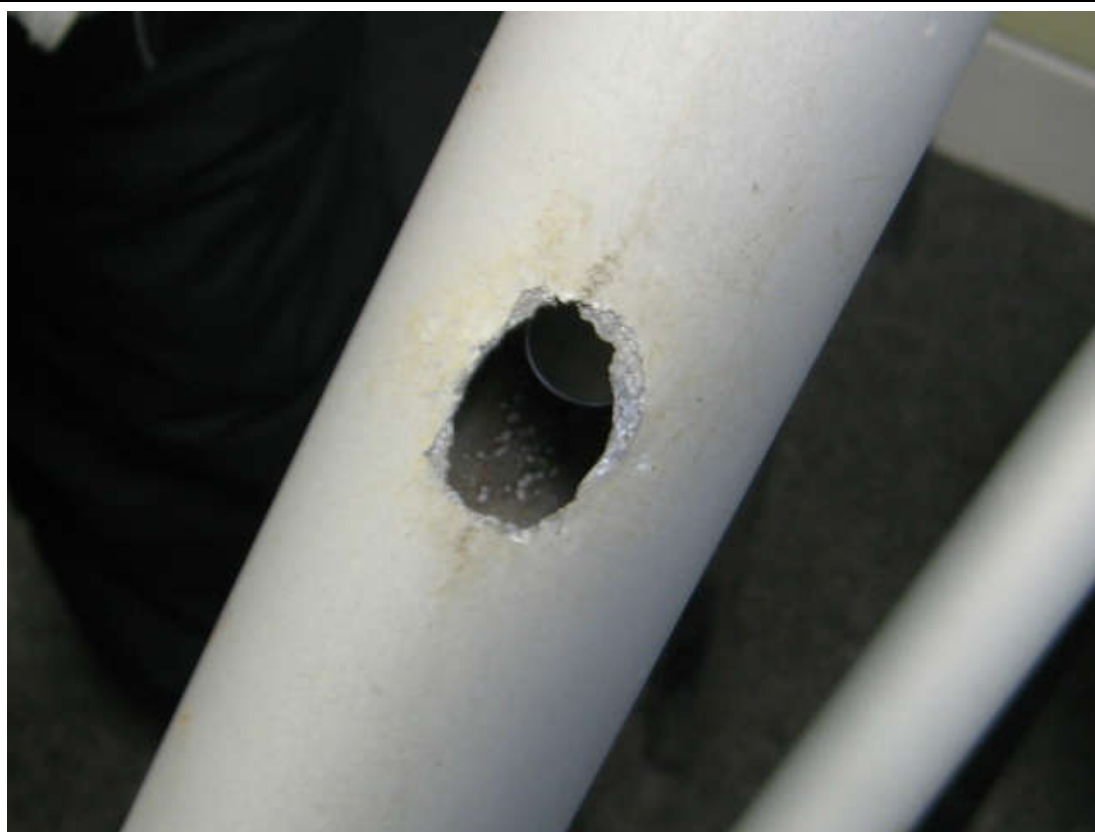
Figure 3, hole where aileron horn passes out lower side of aileron front spar tube (hidden beneath fabric covering in service).
