**Ikarus C42 component advisory**

**C42 fuel filler hose**

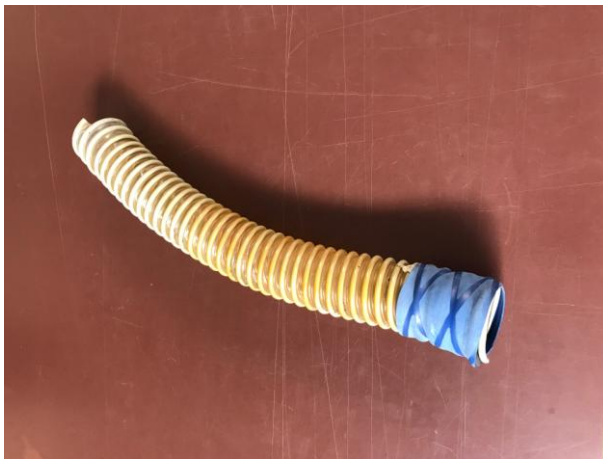
Old Hose

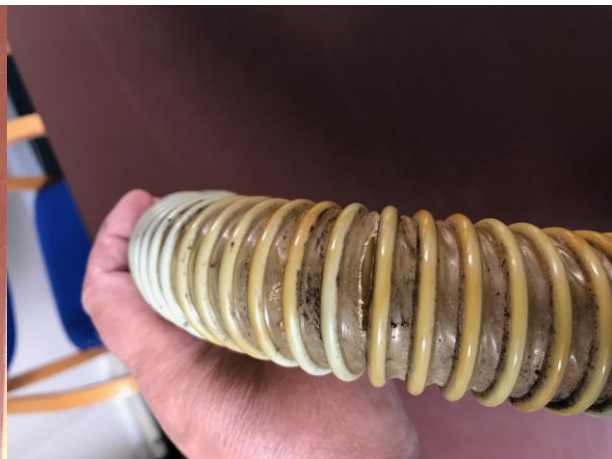
TLAC have had a couple of instances where the fuel filler hose in some C42 aircraft (4 years and older it seems) begins to fail and leaks fuel into the baggage bay or just leaks vapours, still never the less dangerous. The reason for failure would indicate to loss of plasticiser in the wall material probably through ethanol. Splits may be quickly recognised by fuel staining on the exterior of the hose, whilst this is a good indicator it is not a fool proof sign and a thorough inspection should be made at the first opportunity.

Typical hose split

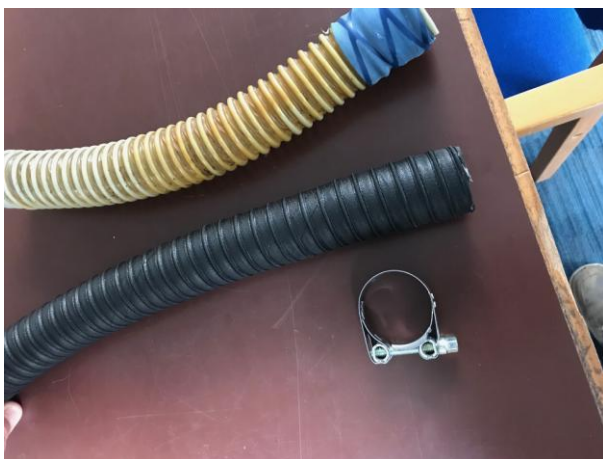
New hose (bottom) and new hose clamp

The factory is now fitting a far better hose and clamp program, but this still leaves older aircraft and owners out there with a potential problem probably unknowingly??

New hose and clamps are available from TLAC.

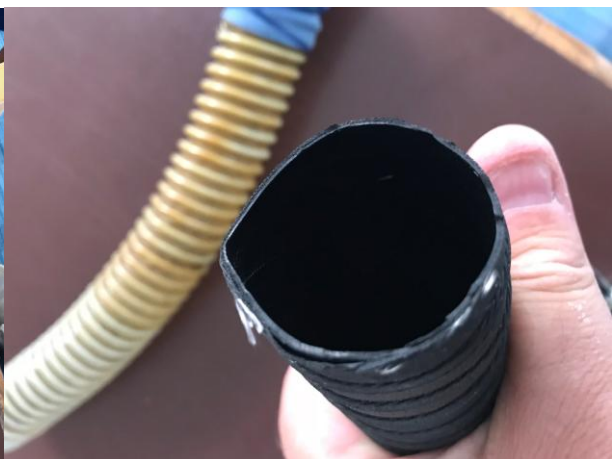
New smooth bore
