## SERVICE BULLETIN INDEX

SB-1	Issue-1	Revised seat harness attachment points
SB-2	Issue-1	Clevis pins with split pins
SB-3	Issue-1	Drain holes in elevator
SB-4	Issue-1	Pitot static tube security
SB-5	Issue-1	Revised fuel filter
SB-6	Issue-1	Exposed terminals
SB-7	Issue-1	Relay supports (sharp corners)
SB-8	Issue-1	Rose joints binding
SB-9	Issue-1	Jury strut clearance
SB-10	Issue-1	Short bolts in critical areas
SB-11	Issue-1	Vapour return system
SB-12	Issue-1	Hinge bolt security
SB-13	Issue-1	Rudder return springs
SB-14	Issue-1	Incorrect screws in critical areas
SB-15	Issue-1	Electrical fuel check valve bypass
SB-16	Issue-1	Elevator horn cracking – factory built
SB-17	Issue-3	Elevator horn cracking – kit built
SB-18	Issue-1	Stub axle cracking
SB-19	Issue-1	Exhaust inspection around cockpit heater jacket
SB-20	Issue-1	Cockpit carbon monoxide detector
SB-21	Issue-1	Seat support tube rotation
SB-22	Issue-1	Incorrect length bolts fitted to cockpit tubes

SB-23	Issue-1	Incorrect length bolts fitted to stub axle
SB-24	Issue-1	Bolts in rudder horn fouling on rear composite
*SB-25	Issue-1	Crack in weld on wing root rib
SB-26	Issue-1	Wing leading edge spar
*SB-27	Issue-1	Engine mount crack

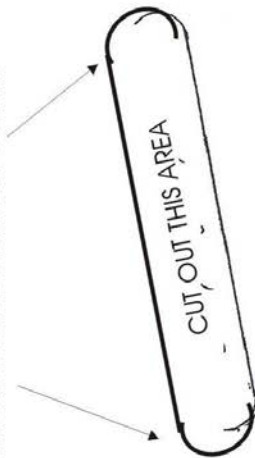
"LINE UP" ON EXISTING SEAT BELT HOLE

DRILL 8-10MM HOLE EACH END  
FORM INTO A SLOT USING "DREMEL" OR EQUIVALENT CUTTER.

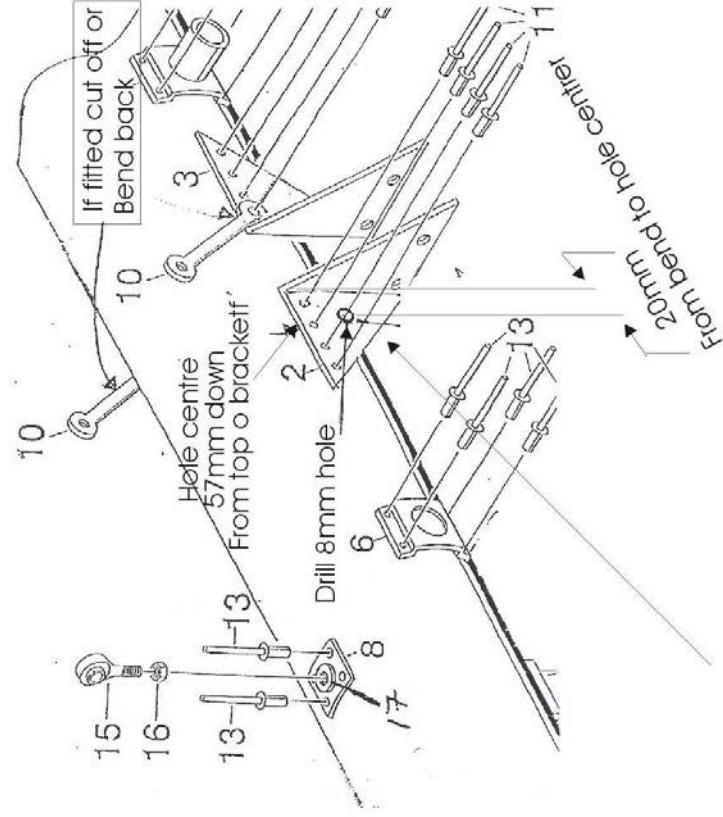
SERVICE BULLETIN No 1[b] Seat Harness Attachment. Issue 2 15-8-2004

The inboard seat attachment points are to be lowered to allow correct positioning of the Lap Straps

NOTE:

When drilling the 8mm hole place a metal sheet  
Behind the bracket to avoid damage to the main tube

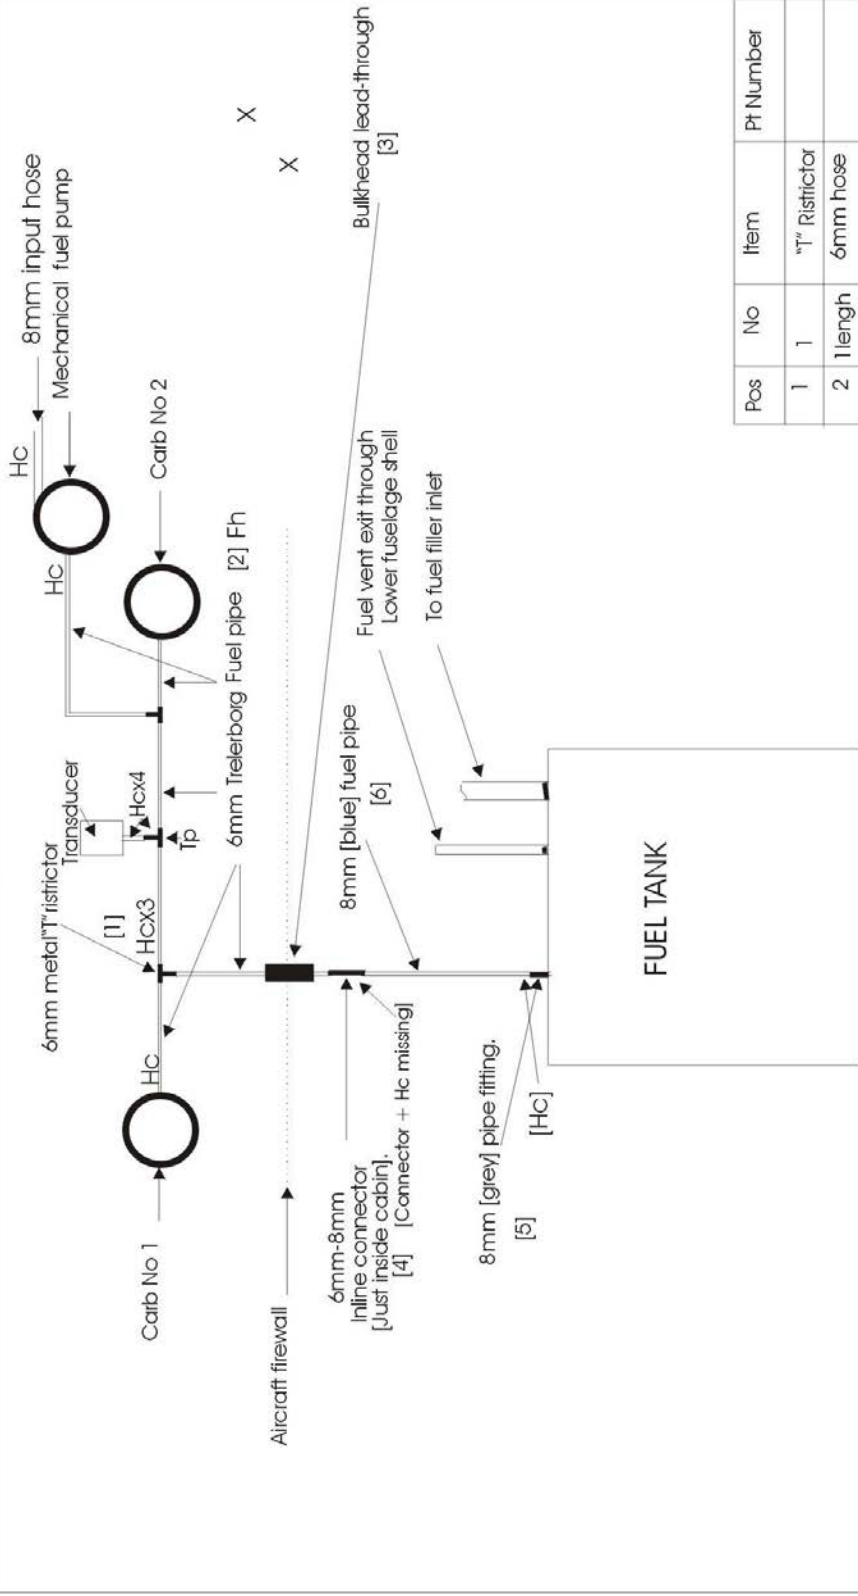
C42FB UK
DRAWING NUMBER
Service bulletin 11 A [additional]
Issue No 1
14-11-2002

# VAPOR RETURN SYSTEM

8. Remove threaded bung from rear of tank and install screw in fitting, fit return hose and secure hose clamp, make sure no debris enters the tank. Carry out leak checks.

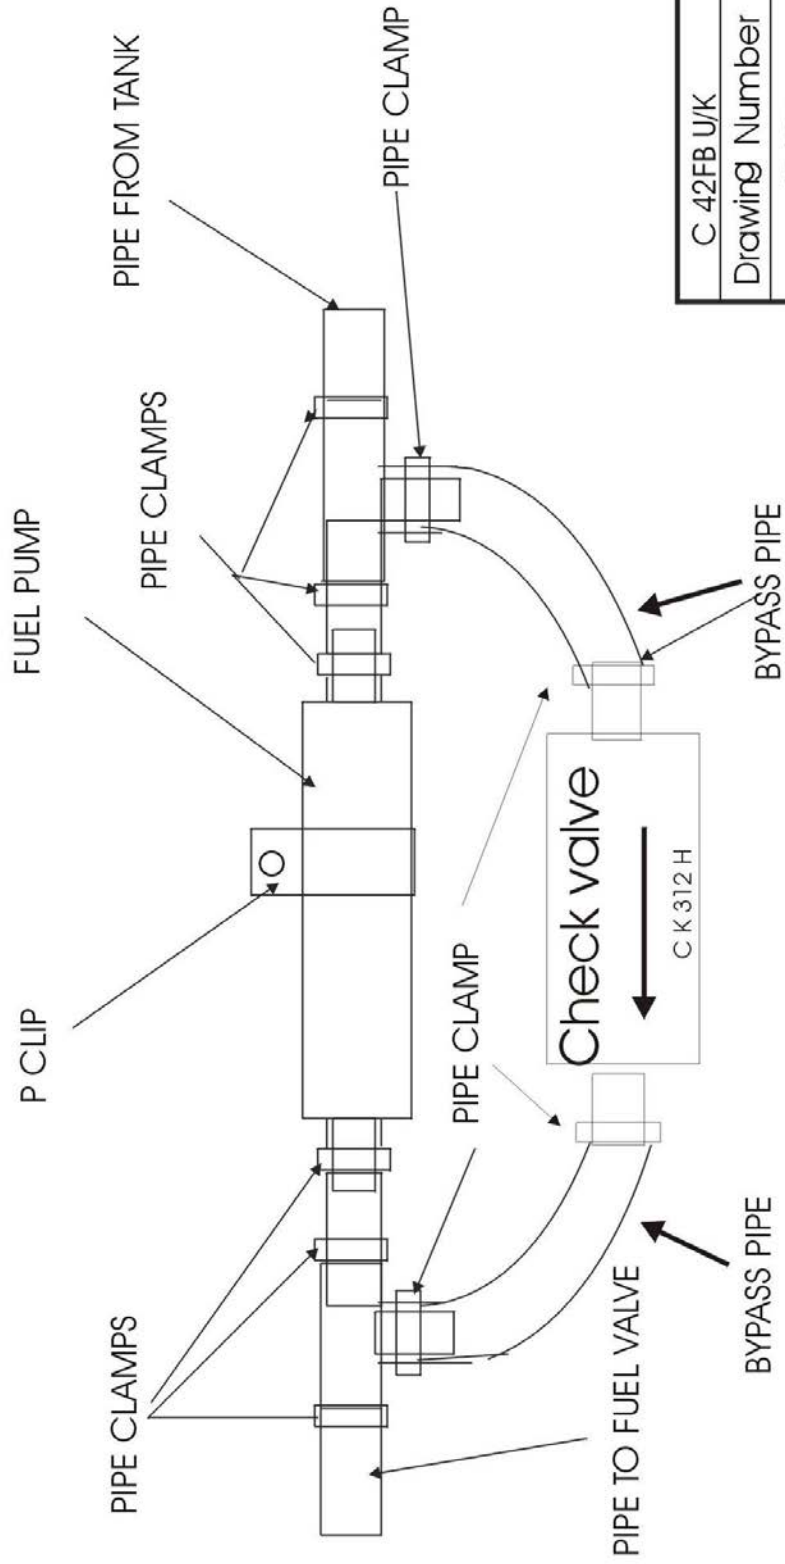
C 42FB U/K
Drawing Number
SB 15a
Issue No 1
Date 5-10-2003

## ANDAIR CK 312 CHECK VALVE
