D-Motor International bvba

Service Bulletin NO. 2019-014/2

SUBJECT : Alternator Flywheel modifications (improvements) Version 2

MODELS AFFECTED : All models on LF26 and LF39 engines**TIME OF COMPLIANCE :** from 11/06/2019, or when due to service**AFFECTED SERIAL NUMBER(S) :** See (*)**Scope :**

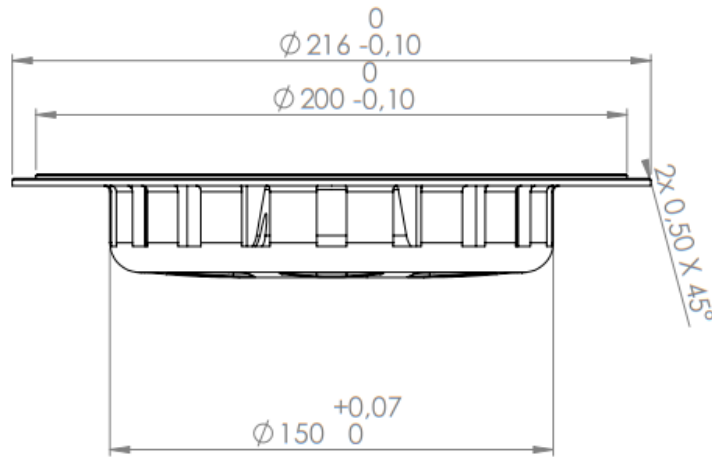
Exploded ASSEMBLY of the modified Alternator Flywheel

The FlyWheel (alternator) structure was modified (structure). the new model is stronger and more resistant to large forces. The fixation was changed. (new special washer added)

The openings on the Flywheel are triangular now, instead of trapezoidal.
The body is thicker.

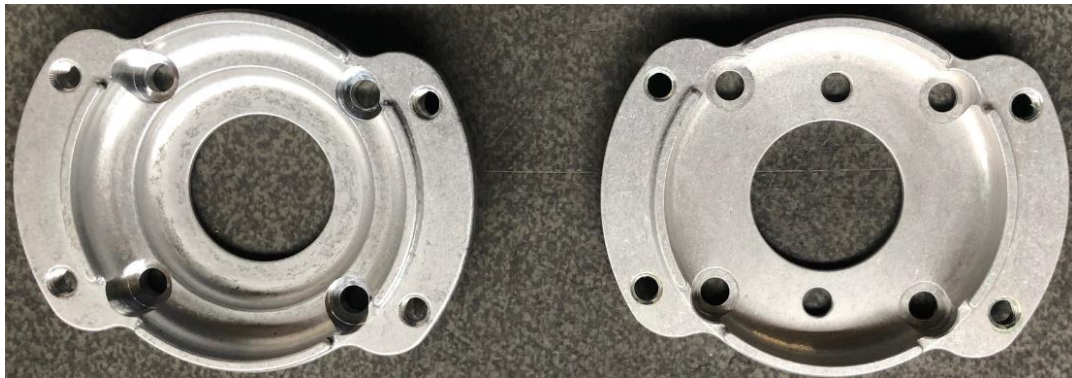
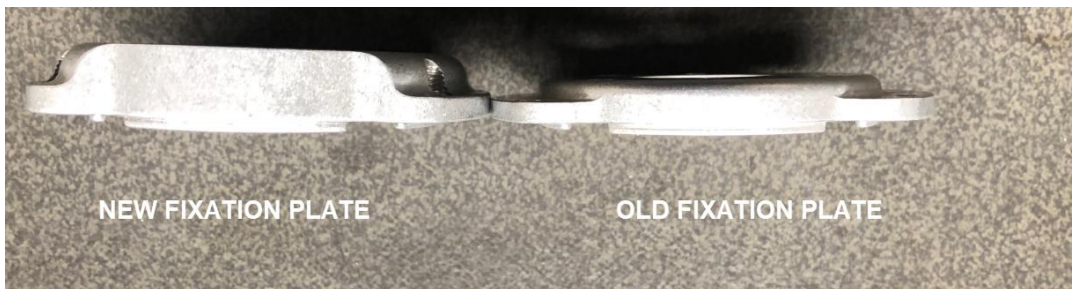
NEW FIXATION PLATE

- >> The flywheel structure is thicker, the fixation plate Coil ↔ Backplate is thicker
- >> The cabling that enters the coil set should change side !!! (in order to prevent damage to the cabling set)

- 1/ disconnect the wiring from connector or box
- 2/ change the wiring from the top side (the side the flywheel is covering the coil set) and guide it to the opposite direction.
- 3/ mount the thicker plate (fixation plate coil – backplate) on the backplate, and mount the coil on the fixation plate, connect the coil wiring again
